Property Inspection Report

1221 N. Harvest Walk Dr, La Puente CA, 91555 Inspection prepared for: John Felix & Jan Felix Agent: Jane Smith - Smith Realty

Inspection Date: 8/1/2007 Time: 3:30 to 5:45 Weather: Sunny

Inspector: Mike Verlingo

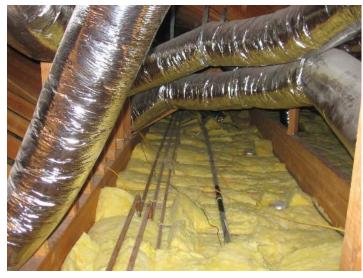
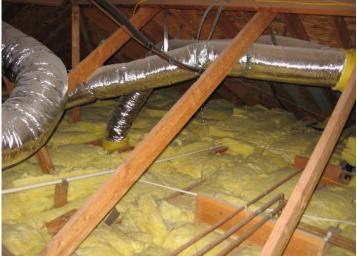
Attic Duct Work

Observations: The duct work appeared functional.

For a thorough inspection I recommend an evaluation by a Heating & A/C contractor.

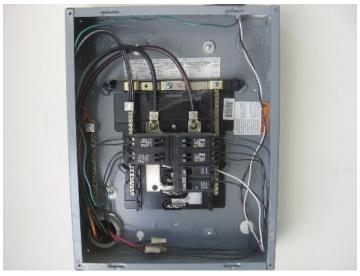
**Electrical Sub Panel**

Observations: Undersized wires to a breaker., There was evidence of water within the panel., I reccommend having a licensed electrician evaluate., 14 gauge wire runs to a 30 amp breaker, improper electrical installation, Undersized wires to a breaker.

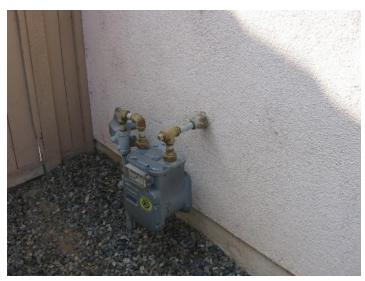
Main Gas Valve

Observations: Main gas into the house is natural gas., No seismic shut off present., I recommend having the Gas Company evaluate the valve.

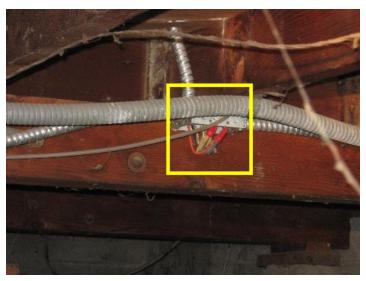
Exposed electrical connections. Missing junction box cover.

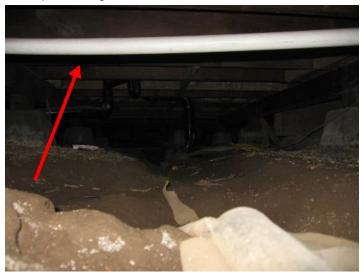
Foundation Plumbing

Observations: The foundation plumbing could not be accessed.

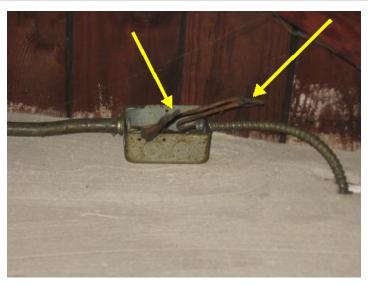
Missing wire nuts

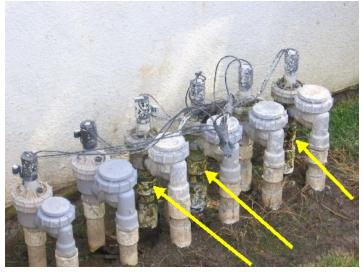
The system was tested and worked. Visible leaking of sprinker valves.

Visible leaking

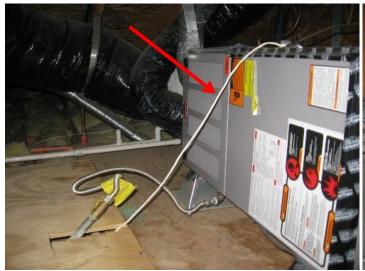
**Heating Heater Condition**

Observations: Both heaters were functional. Cable wire for television runs over the heater

Downstairs heater view.

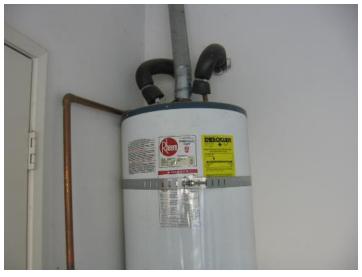
Water Heater

Observations: Water heater operated normally., Evidence of leaking was seen on the water heater

base.

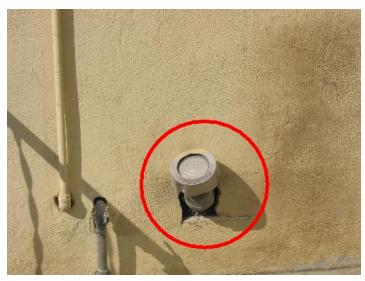
Observations: The vent could not be fully inspected due to limited space.

Improper installation of vent pipe. Exhaust vent from water heating in the basement area.
