PROPERTY INSPECTION REPORT

Client: Jane Aardvark Property: 11160 Trails End Ct Rancho Cucamonga, HI 91737 Date: 2/20/2021 - Time: 07:00 AM

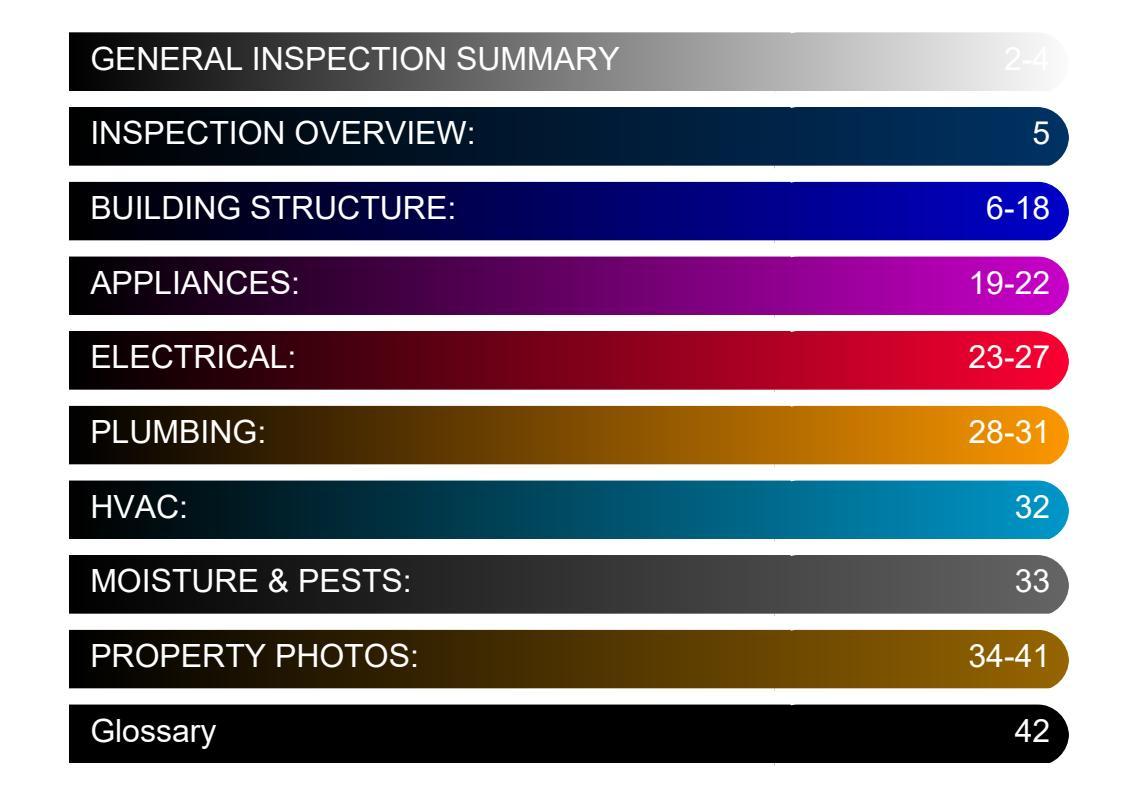
GENERAL INSPECTION SUMMARY

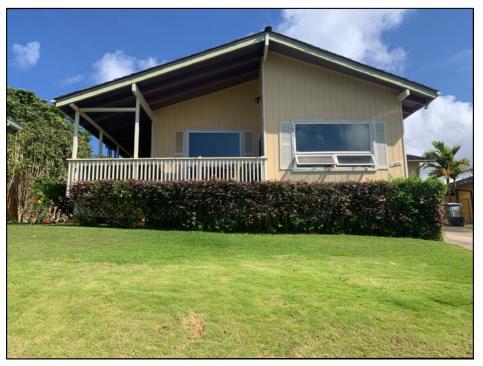
PHOTOS AND DETAILS OF DEFECTS AND DAMAGES NOTED IN THE SUMMARY ARE FOUND IN THE BODY OF THE REPORT. PLEASE READ THE ENTIRE REPORT. A PHOTO OF A DEFECT DOES NOT MEAN THE THE ISSUE WAS LIMITED TO THAT AREA ONLY BUT MAY BE A REPRESENTATION OF A CONDITION FOUND IN OTHER AREAS.

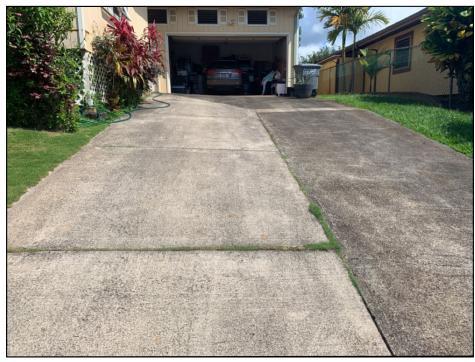
Driveway - Concrete.

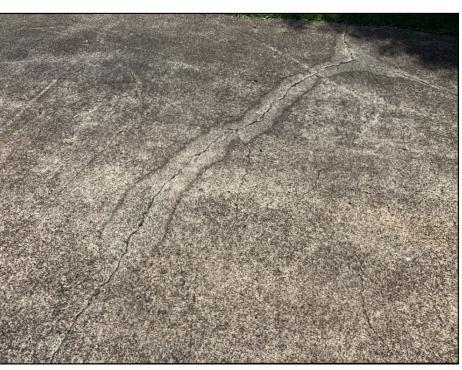
Cracks at concrete slabs are common and are typically cosmetic in nature. There was no indication the cracks observed were a significant defect.

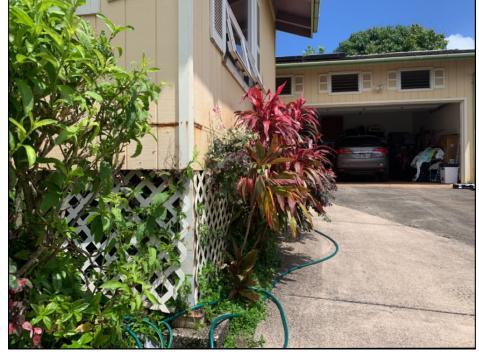
Landscaping or vegetation was near or in contact with the home. Maintain to prevent damage and moisture intrusion to structure. (Blue)

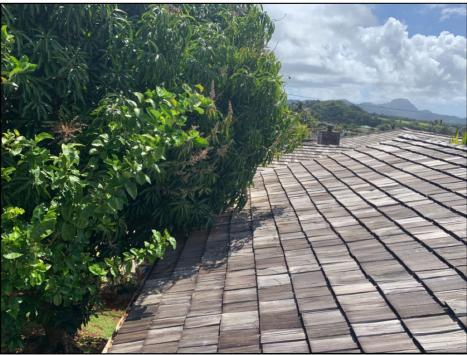
Tree branches were near or in contact with the roof and siding. Maintain to prevent damage to structure and roof. (Blue)

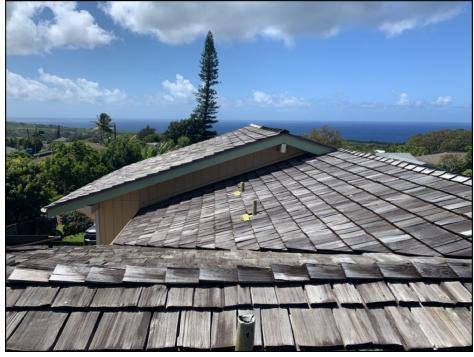
Roof inspection - Roof was walked. Roof materials - Wood shakes.

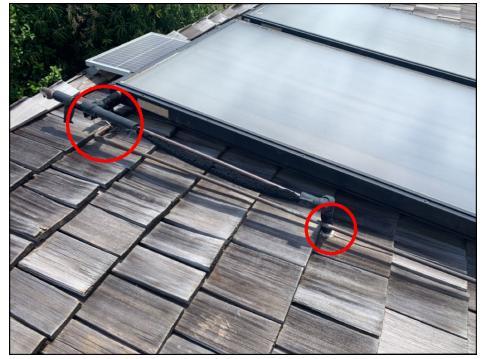
Solar water heating roof penetrations did not appear to be adequately sealed. Indications of a leak with damaged drywall at the garage ceiling. Repair or replace components as needed. (Red)

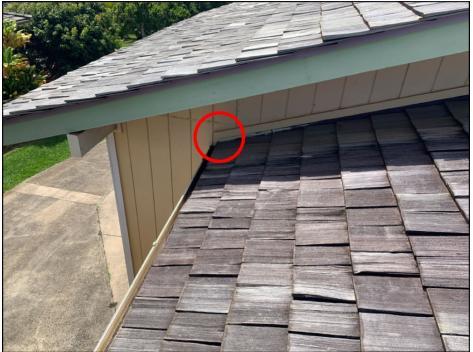
Kickout flashings were missing where the wall continued past the roof. Kick out flashing divert waters away from the structure and helps prevent damage to walls. There were no significant damages to the siding at this location however installation recommended time the roof is replaced. (Blue) Location: right side of home.

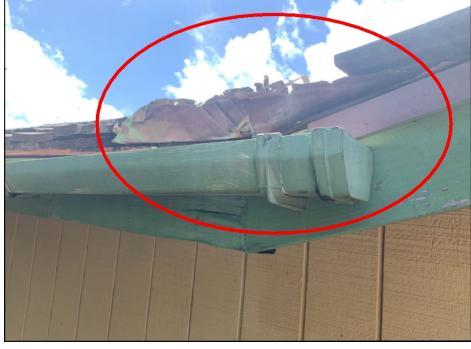
Damaged flashing. Exposed plywood underlayment and damaged eave and facia board. Evaluate. Repair or replace as needed. (Red) Location: rear of garage at rear lanai.

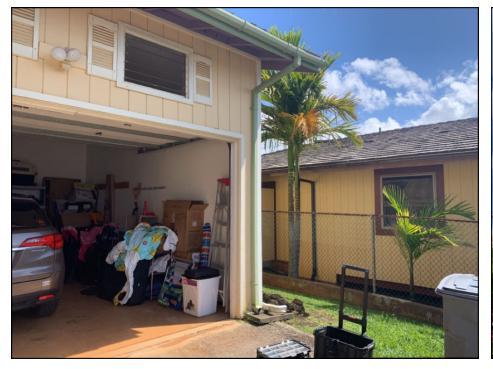
Rain gutter materials -Plastic.

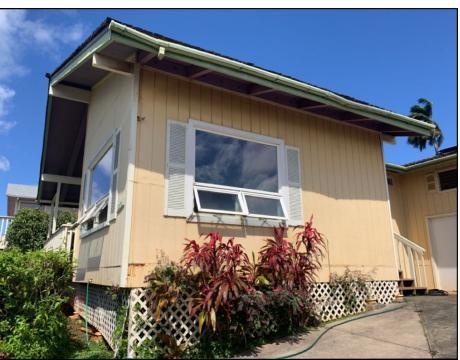
Missing downspout in the rain gutters were not properly secured. Repair or replace as needed. (Red) Location: right side of the home.

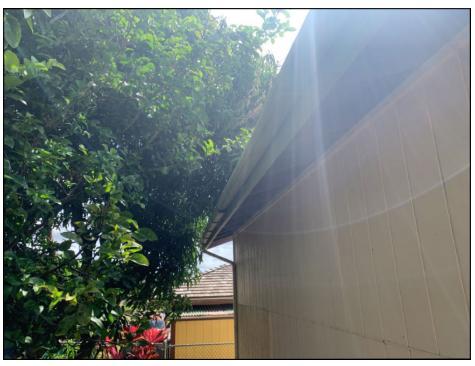
Disconnected rain gutter. Repair. (Red) Location: rear of garage.

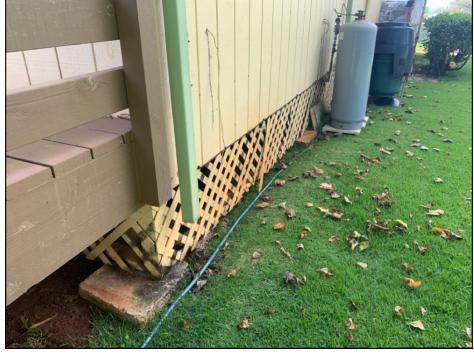
The roof drainage system channels water away from the foundation. Water from the roof can raise the moisture content in soil near the foundation which can affect its ability to support the structure and may cause foundation damage. Direct rain gutter drainage away from foundation components to prevent damage. (Red)

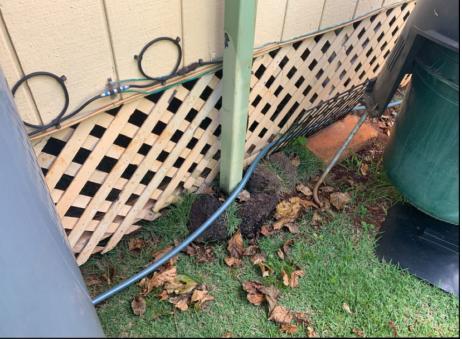
Remove debris from gutters to ensure proper function. (Red)

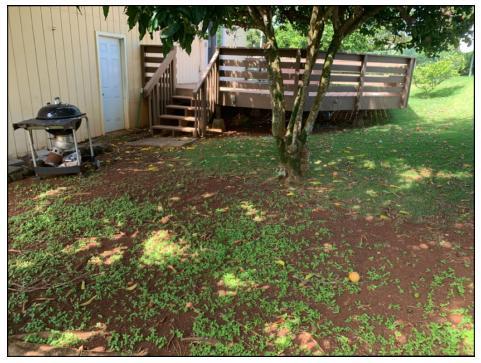
Moisture intrusion at foundation area components can cause serious structural issues over time. A drainage plan should be designed and installed to direct water from designed and installed to direct water from the grade and rain gutters around the

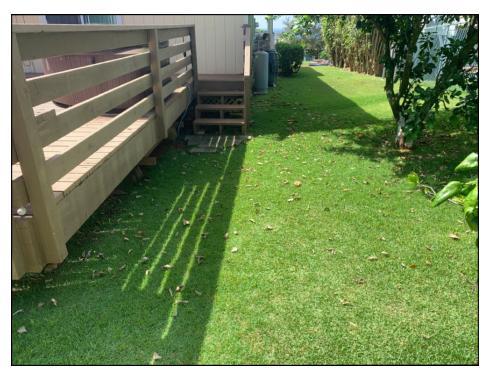
The grading was sloped towards the home. The grading was sloped towards the home. Damage observed to siding at garage. Moisture intrusion at foundation area components can cause serious structural issues over time. A drainage plan should be the grade and rain gutters around the structure to prevent water accumulation against or under the home. (Red)

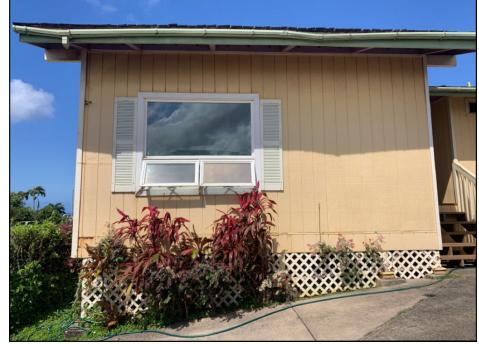
Exterior wall material(s) - T-1-11 plywood siding., Wood trim at doors and windows.,Wood trim at building corners., Double wall construction.

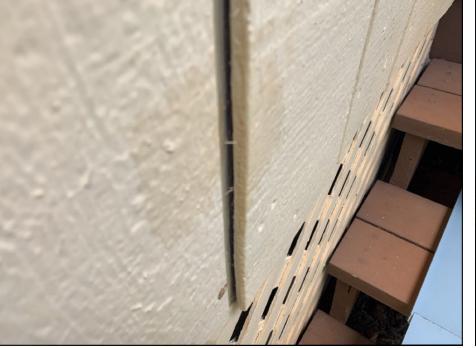
Seal gaps, cracks and penetrations at the exterior walls and trim to prevent moisture and pest intrusion. (Blue)

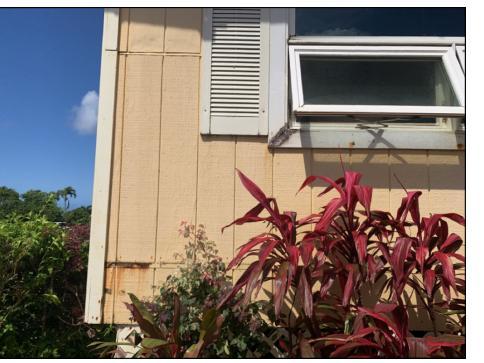
Minor to moderate damage at siding and trim, possibly due to missing rain gutter downspout above. Evaluate. Repair rain gutter. Repair or replace siding and trim components as needed. (Blue)

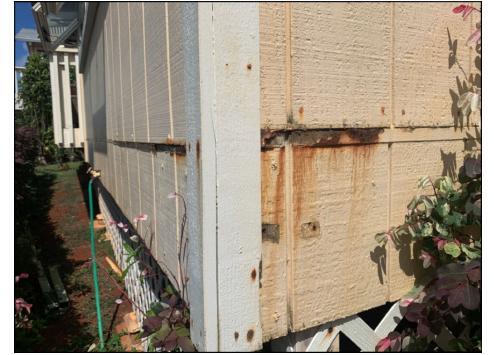
Corrosion at wall flashing. Repair or replace as needed. (Blue) Location: Photo location at front right of home. Condition exists at a few locations around the home.

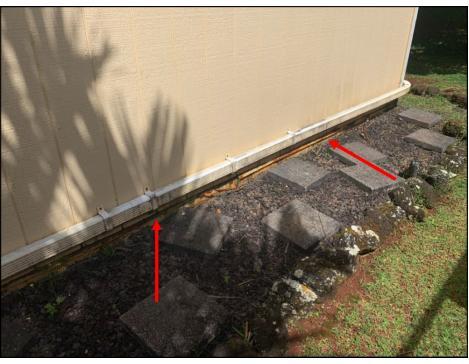
Corrosion at wall flashing. Indication of moisture damage at sill plate visible from inside of garage. Evaluate. Repair or replace as needed. (Red) Location: Garage.

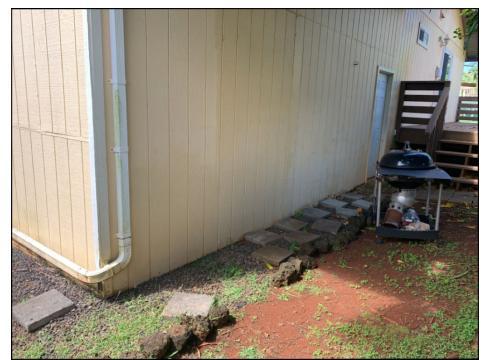
Damage siding and trim. Repair or replace as needed. (Blue) Location: rear of garage.

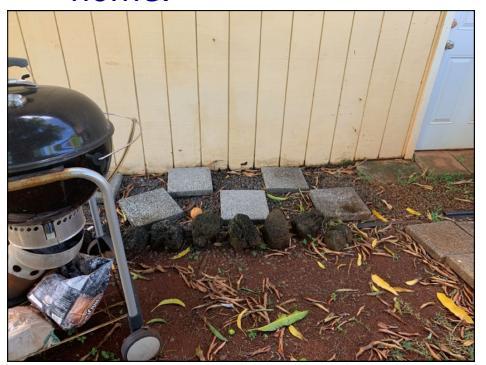
Soil/gravel/vegetation in contact with siding/trim components. DamThe condition to prevent further damage. (Red) Location: of the wall inside the garage was not clearly rear of garage at rear lanai. visible due to personal belongings. Evaluate the condition of the wall and repair the grade to prevent further damage. (Red)

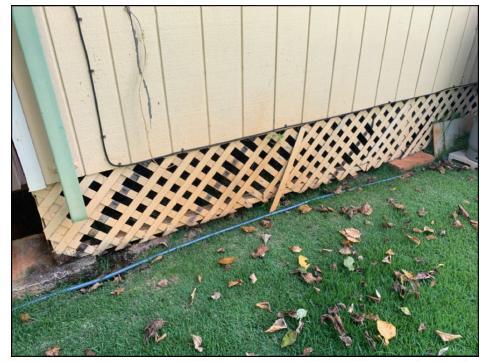
Damaged lattice foundation skirting got a few locations around the house. Repair or replace as needed.

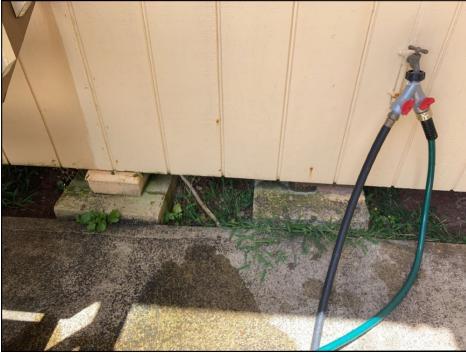
Damaged wood foundation post. Repair or replace as needed. (Red) Location: right side of home adjacent to main entry deck.

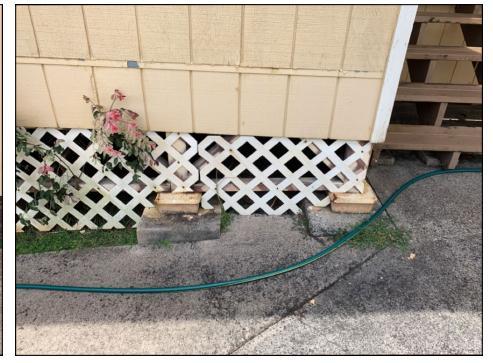
Damaged wood foundation post. Repair or replace as needed. (Red) Location: left side of home adjacent to main entry deck.

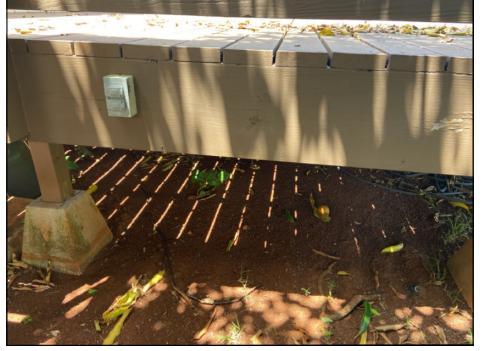
Foundation access. Location: rear of home below lanai.

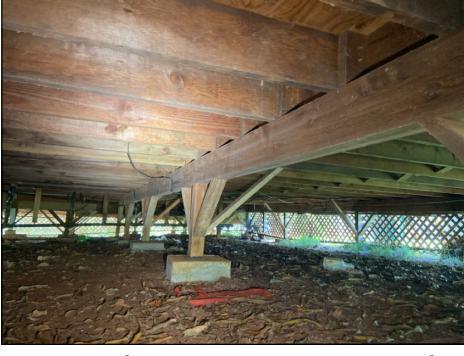
Foundation type - Raised foundation(s) inspected by walking or crawling under the home or structure(s) and/or remote control car with camera.,Concrete piers.,Wood posts.,Floor system: 4X wood beams and 4 X wood joist.,Plywood over floor joists.

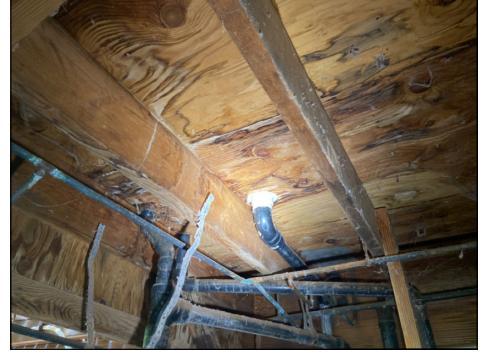
Stains or minor water damage at sub-floor. Normal moisture levels at time of inspection. Location: below master bathroom.

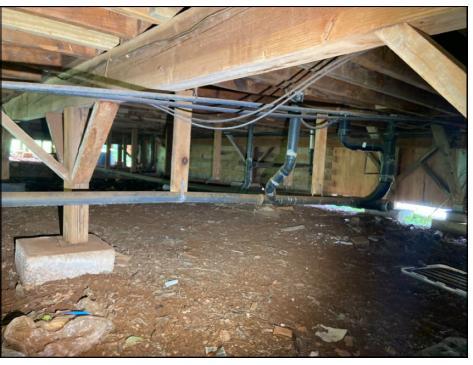
DECK/LANAI STRUCTURE:

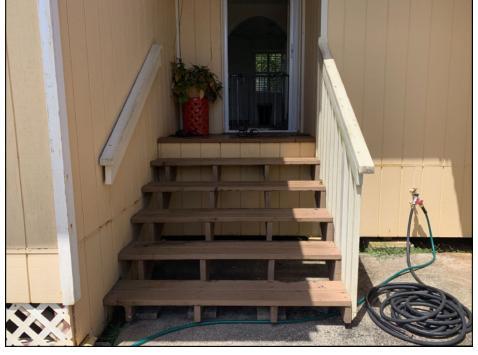
There were components at the deck surfaces or structure that could be updated to meet current safety or building standards.

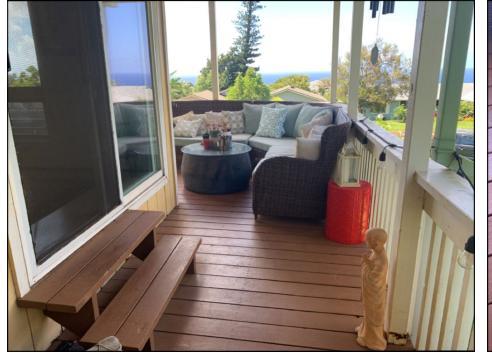
Deck/lanai description/location - Front of home. Surface/structure - Wood decking over wood joists. Handrails - Wood.

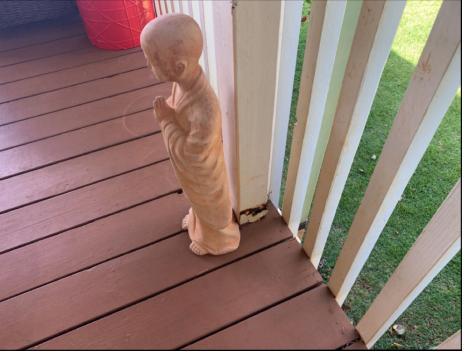
Corrosion at post base. Replace. (Blue) Location: front lanai.

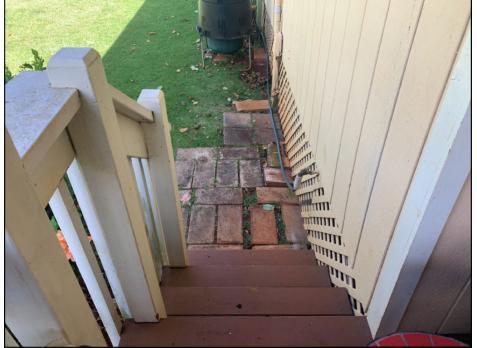
Current safety standards indicate that stairs with 4 or more risers should be equipped with a safety rail and graspable handrail. Update as needed. (Purple)

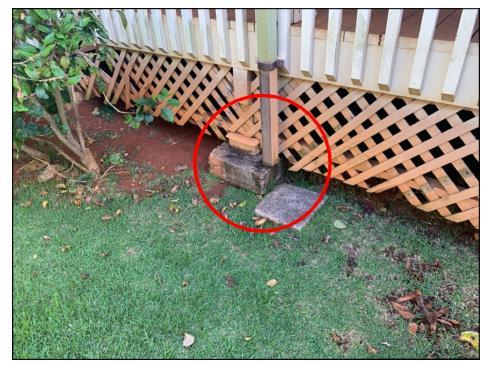
Rain gutter downspout discharges near deck foundation pier. Direct rain gutter discharge away from foundation components. Minor to moderate soil loss at deck foundation pier. (Red) Evaluate. Repair or replace as needed.

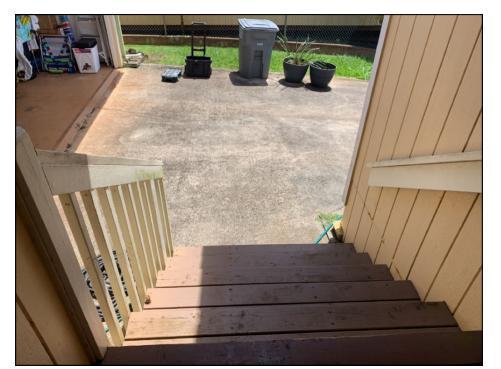
Current safety standards indicate that stairs with 4 or more risers should be equipped with a safety rail and graspable handrail. Update as needed. (Purple)

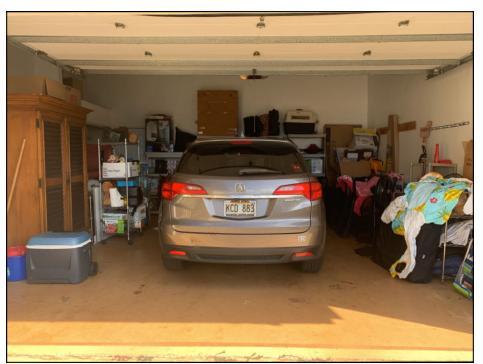
Attached 2 car garage., Sectional door with motorized opener and safety sensors were tested and functioned normally.

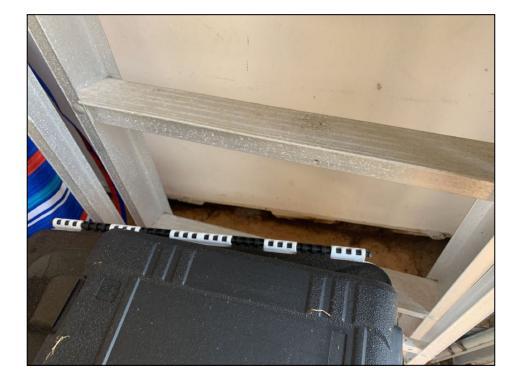
Damaged wood sill plates at right side of garage wall. Indications of moisture intrusion from water drainage. Limited view and accessibility due to personal belongings. Evaluate. Repair or replace components as needed. (Red)

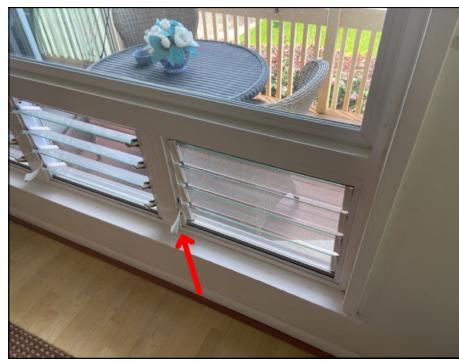
Missing, damaged or corroded window hardware observed. Repair or replace as needed. (Blue) Location: dining area.

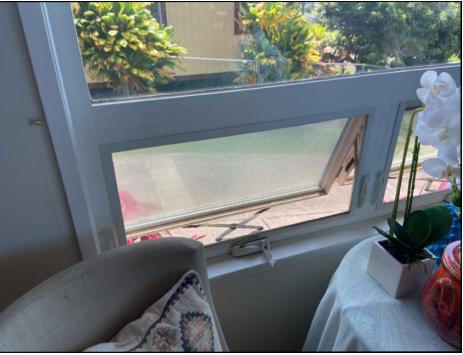
Window(s) did not operate properly. Repair as needed.

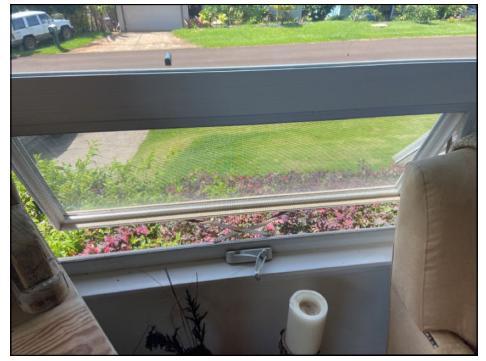
Window(s) did not operate properly. Repair as needed. (Blue) Location: living room. (Blue) Location: living room.

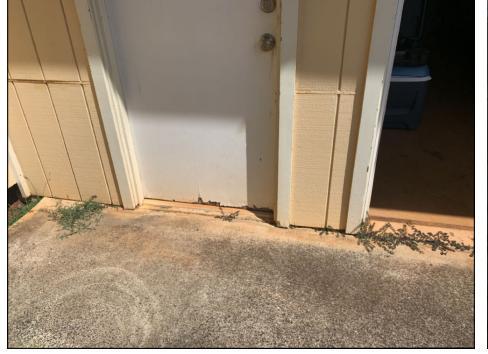
Minor to moderate damage Loose slider door handle. Sliding screen door(s) did to door(s). Maintain or repair Adjust or repair as needed. not operate smoothly. Repair as needed. (Blue) Location: (Blue) Location: dining area. or replace as needed. (Blue) front of garage.

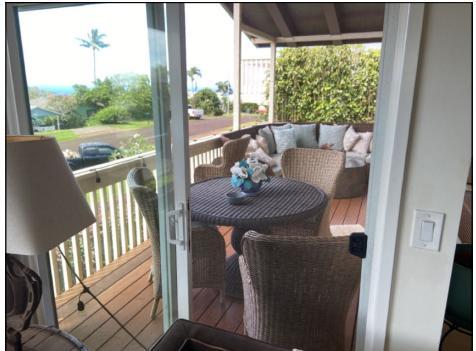
Location: living room.

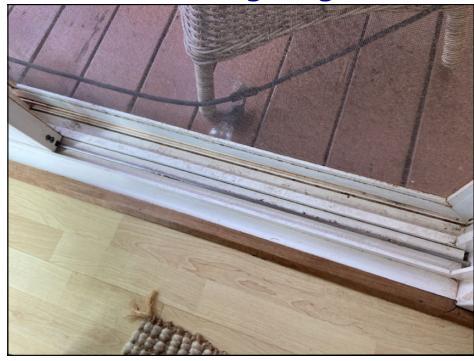
Corrosion common to our climate at sliding screen(s). Repair or replace as needed. (Blue) Location: living room. separation between garages

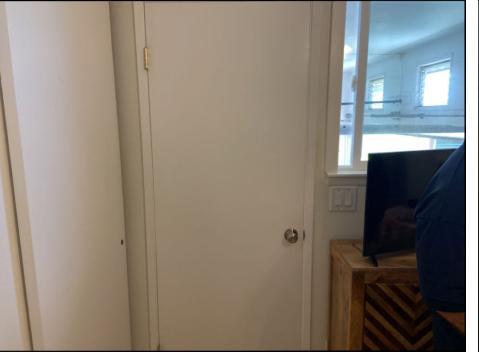
Door from garage to home did not meet the requirements for fire and homes. Replace. (Red)

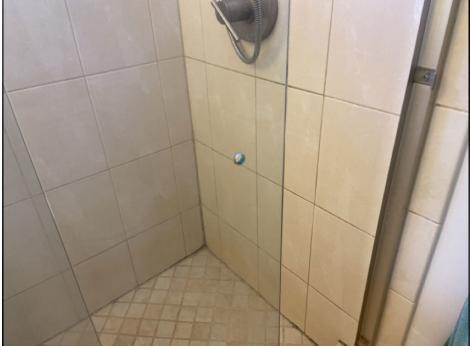
Missing sliding shower door handle. Install. (Blue) Location: master bathroom.

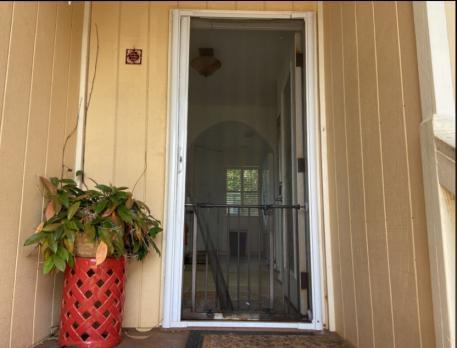
Damaged screen at screen door(s). Repair as needed. (Blue) Location: front door.

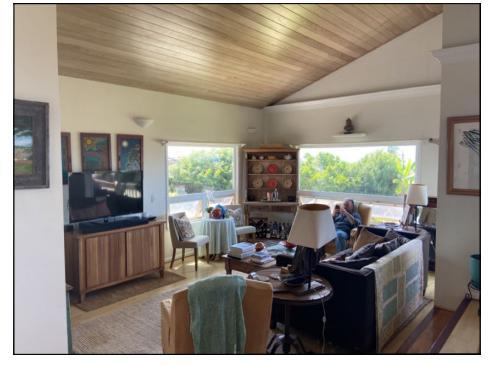
Floors - Porcelain or ceramic tile.Wood. Walls - Drywall. Double wall construction. Ceilings - Vaulted open beam with tongue and groove wood. Drywall.

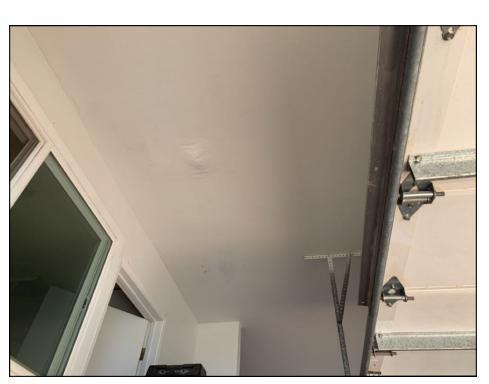
Drywall at garage was damaged due to solar hot water penetrations. Repaired or replace as needed. (Blue)

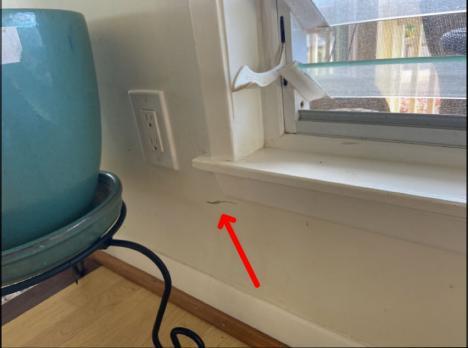
Minor cosmetic defects and damages at walls.

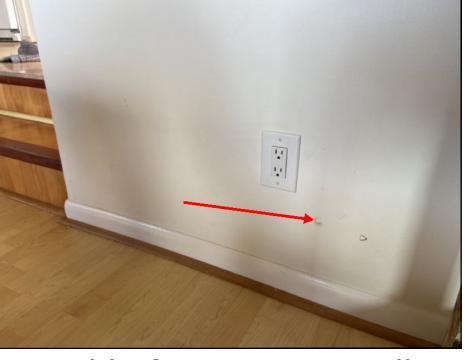
Visible fasteners at wall. Normal moisture levels during time of inspection.

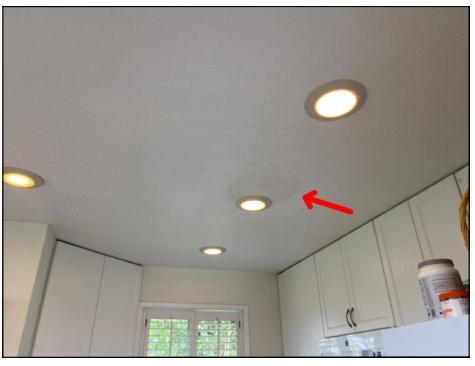
Discoloration or defects at ceilings. Normal moisture levels at time of inspection. Location: kitchen.

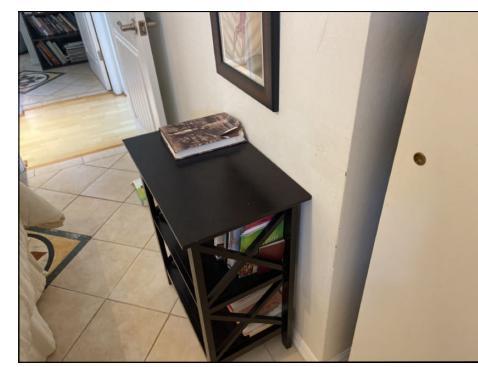
Minor cosmetic defects and damages at walls.

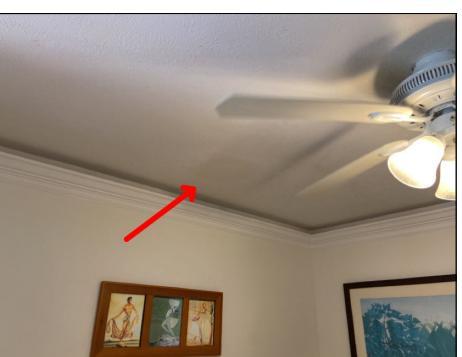
Discoloration or defects at ceilings. Normal moisture levels at time of inspection. Location: guest bathroom.

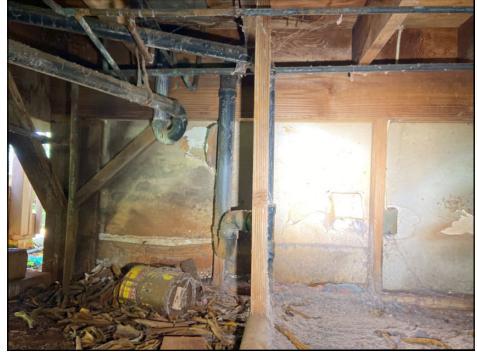
Damage to drywall on foundation side of wall behind the washer and dryer units. Evaluate. Repair or replace as needed. (Blue)

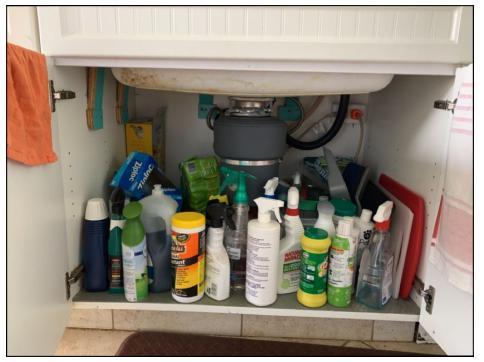
Personal belongings at kitchen sink cabinet. Recommend review prior to cabinet. Recommend review closing to check for damages or defects.

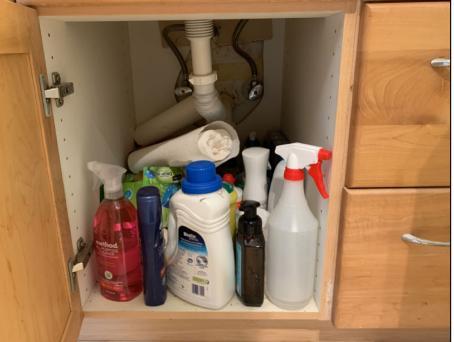
Personal belongings at master bathroom sink prior to closing to check for damages or defects.

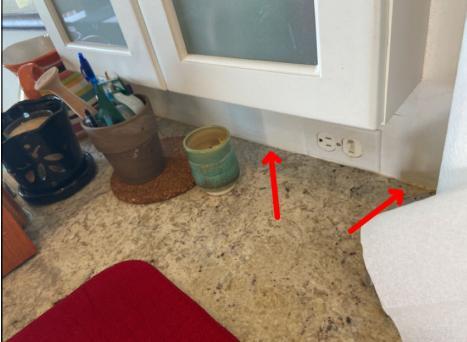
Cracked grout or missing/damaged sealant. Seal to prevent moisture intrusion. (Blue) Location: kitchen backsplash.

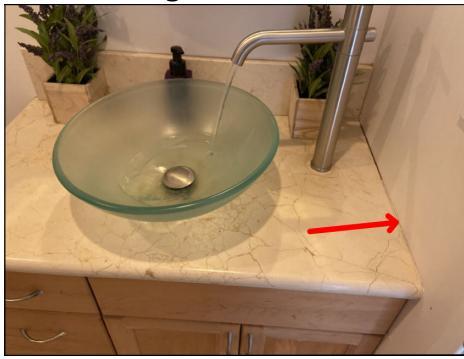
Cracked grout or missing/damaged sealant. Seal to prevent moisture intrusion. (Blue) Location: quest bathroom.

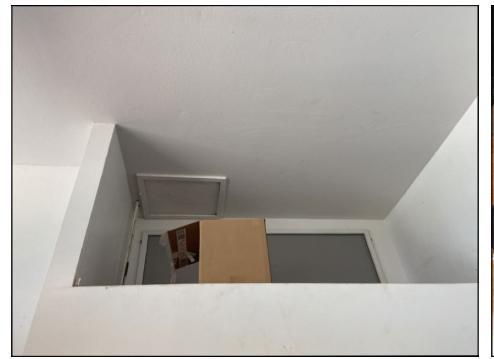
Attic access at Garage.

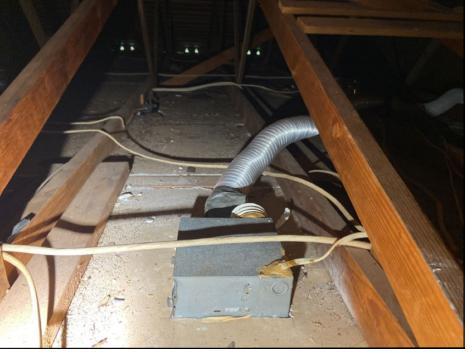
Bathroom exhaust fan(s) were not connected to the exterior venting. Repair. (Blue) Location: master bathroom.

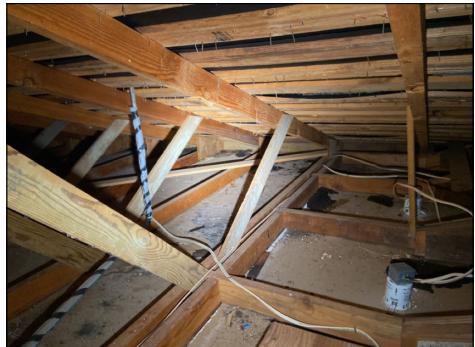
Insulation not present. The lack of insulation is not considered a defect in Hawaii.

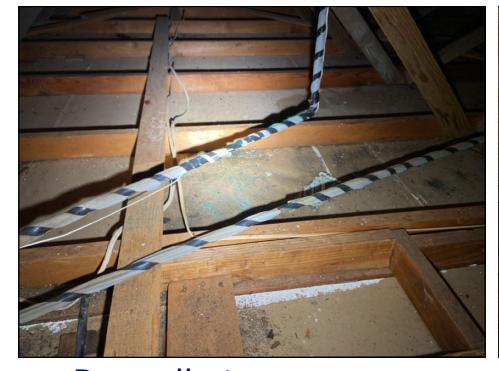
Drywall at garage was damaged due to solar hot water penetrations. Repaired or replace as needed. (Blue)

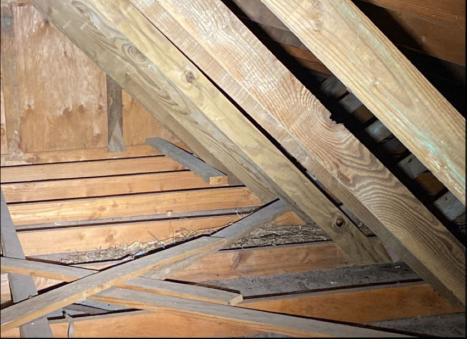
Bird nest(s) was observed in attic. Remove. (Blue)

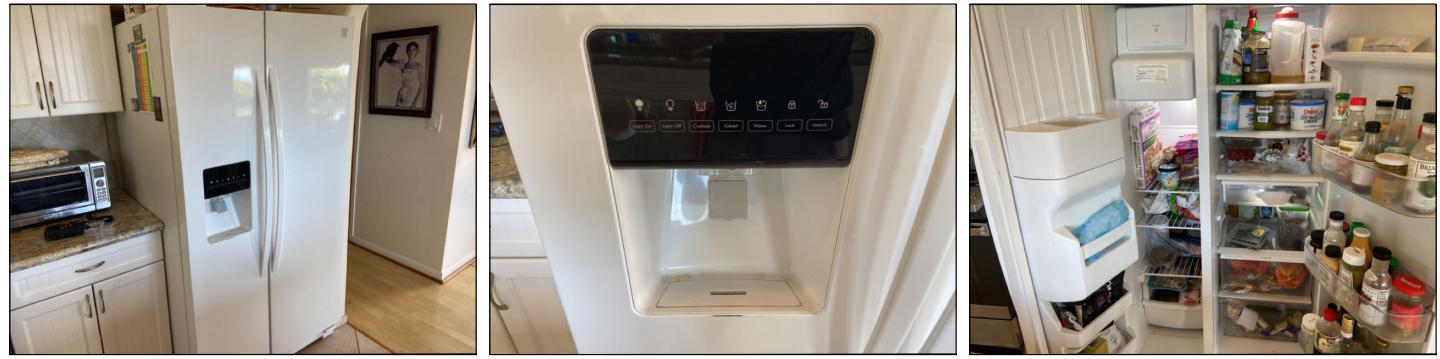
Water and ice dispenser appeared to functioned normally.

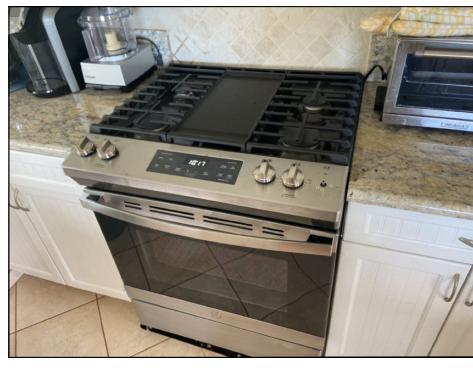
There were defects, damages or safety issues at the range, exhaust hood or microwave oven that need evaluation, repairs or replacement in the near future.

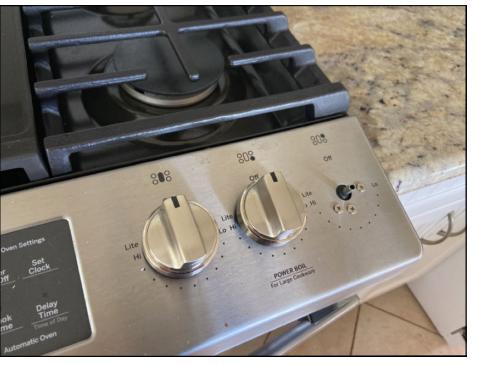
The inspector could not installed. Recommend verifying installation of this important safety device. More info: https://www.nachi.org/antitip.htm

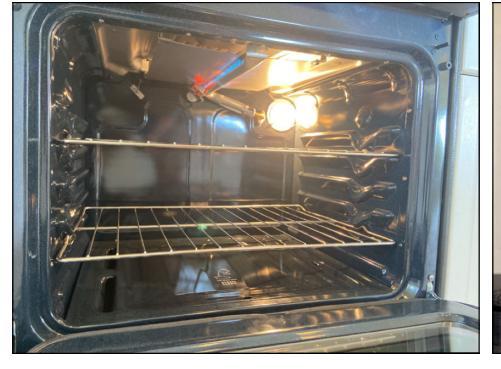
Missing, worn or damaged control buttons. Repair as needed. (Blue)

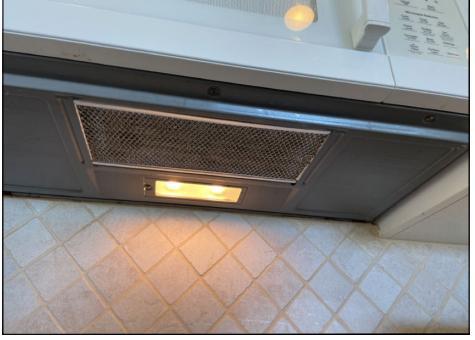
DISHWASHER & DISPOSAL:

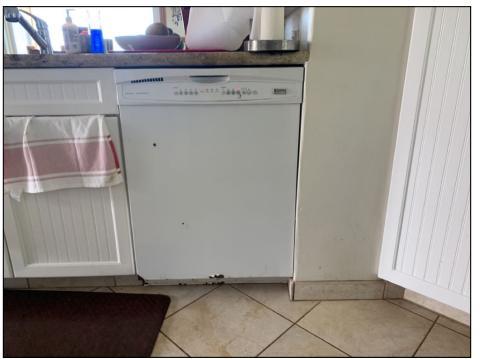
11160 Trails End Ct, Rancho Cucamonga, CA

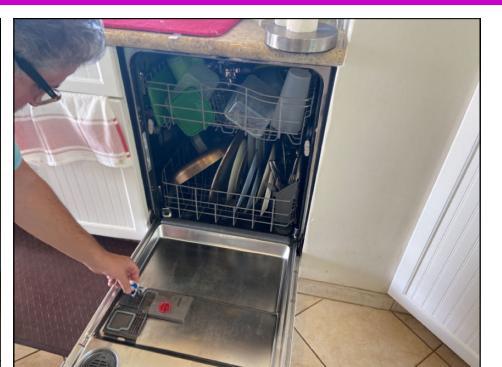
Corrosion at dishwasher. Appeared to be an older unit.

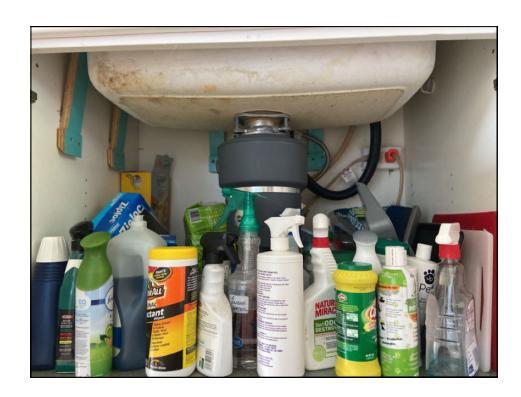
Corrosion common to our tropical climate at dishwasher unit. Monitor and maintain as needed.

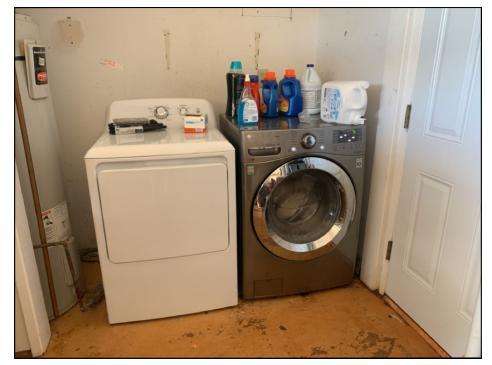
There were defects, damages or safety issues at the washer or dryer that need evaluation, repairs or replacement in the near future.

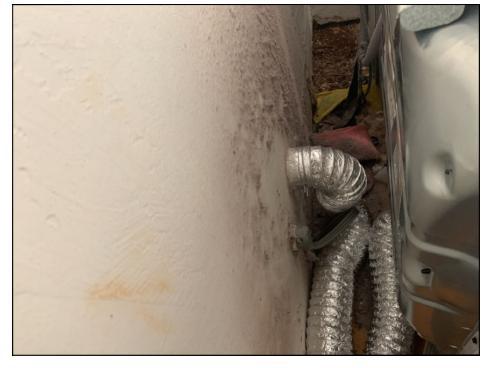
Visible lint, damaged or improperly installed duct or clogged vents. Repair. (Red)

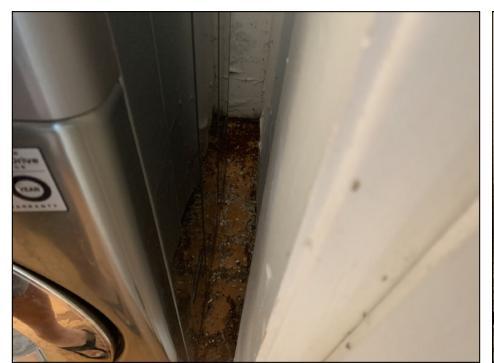
11160 Trails End Ct, Rancho Cucamonga, CA

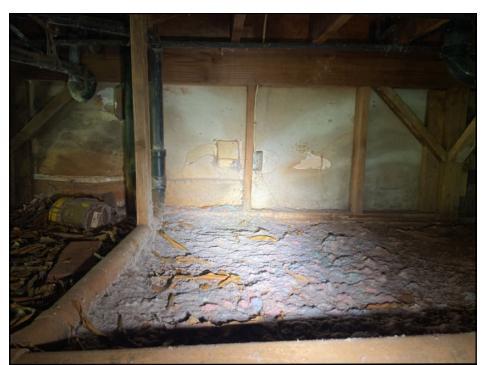
Large amount of lint at foundation area. Fire hazard. Remove lint and direct dryer duct to the perimeter of the home. (Red)

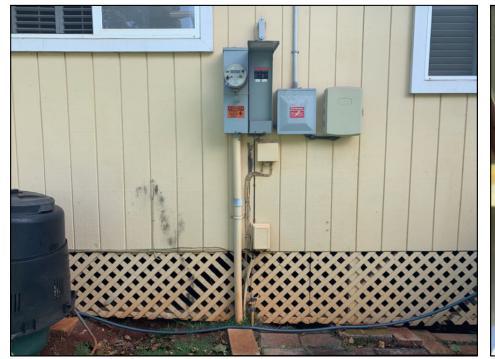
The main disconnect breaker was located at the meter panel at the left side of the home. Electric service - The electrical service wires were underground. ,The electrical service wires were copper.,The electrical service was rated for 100 amp..

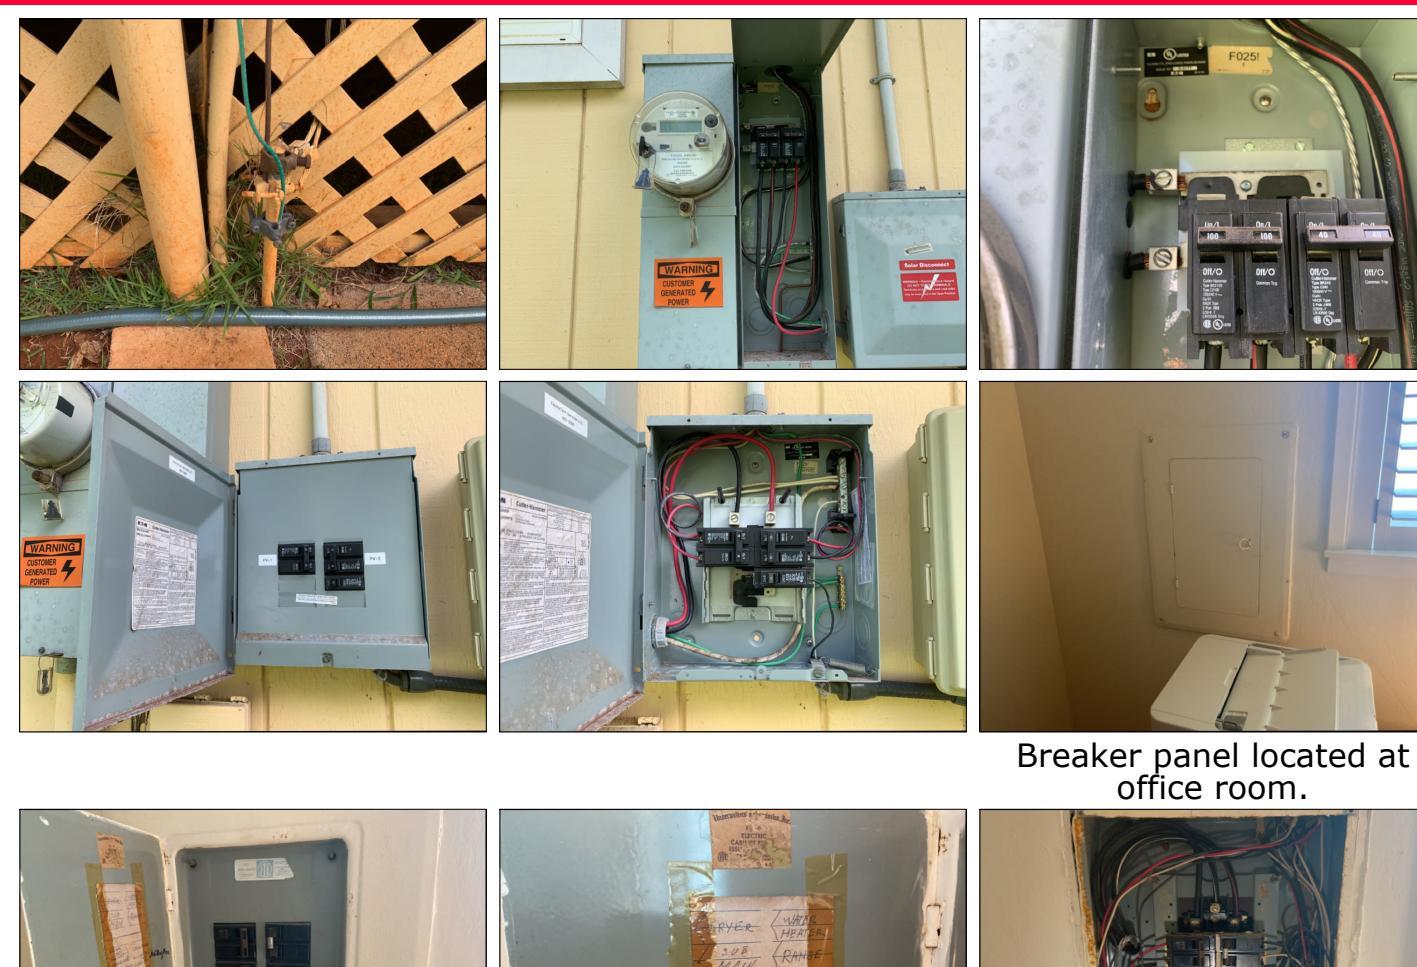
11160 Trails End Ct, Rancho Cucamonga, CA

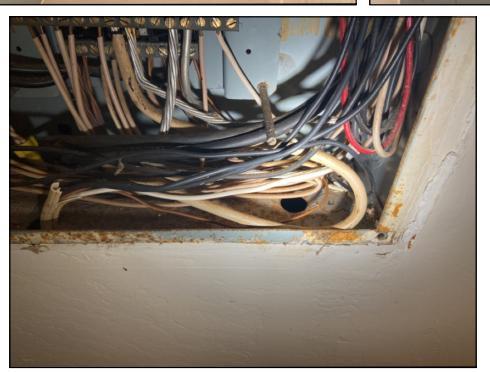
Missing knockout plugs. Helps prevent pests from entering the panels. Install. (Red) Breaker panel had breakers installed that are not the same brand as the panel.

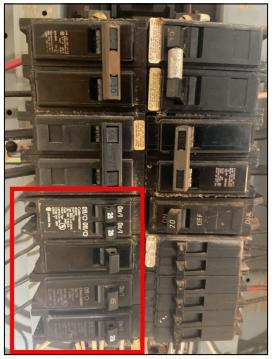
Breaker panel had breakers installed that are not the same brand as the panel. Evaluate to determine the breakers that were installed are acceptable replacements. Replace as needed. (Red)

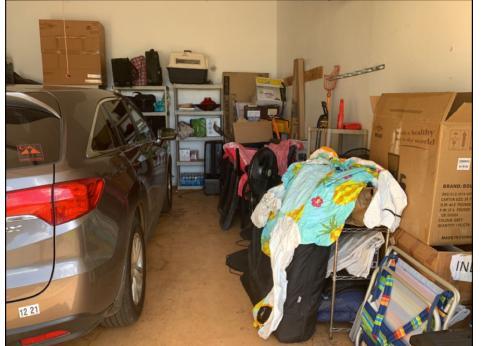
Garage outlets were not tested for GFCI protection because if one were to trip as it should when tested, we may not be able to locate the reset button to turn it back on. Review prior to closing. If the garage outlets are not **GFCI** protected we recommend upgrading to current building or safety standards.

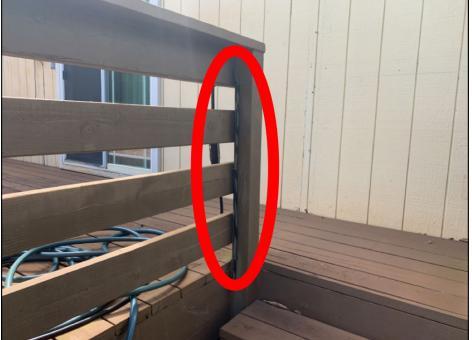
Electrical wiring rates for exterior use.

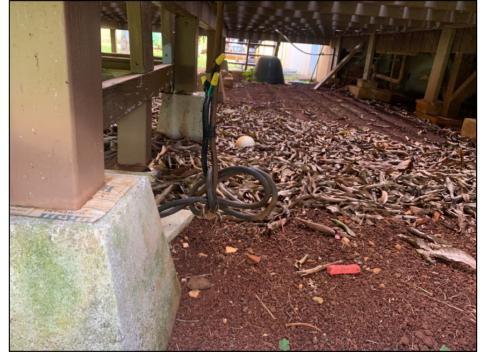
Electrical wiring that is not in use that is energized should be secured and junction boxes. Repair. (Red) Location: below hot tub.

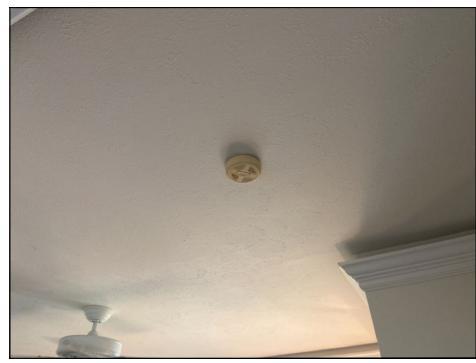
Smoke detector(s) were Recommend replacement. (Red)

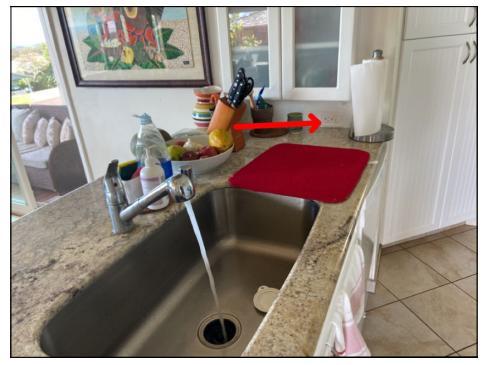
Outlet did not respond to GFI damaged or appeared to be test and did not appear to be past their expected life span. GFI protected. Outlets within 6' of a water source are highly recommended to have GFI protected outlets installed. (Red) Location: kitchen.

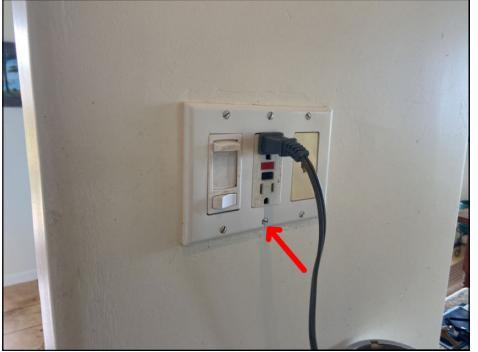
Missing/damaged cover plate(s). Replace. (Red) Location: kitchen.

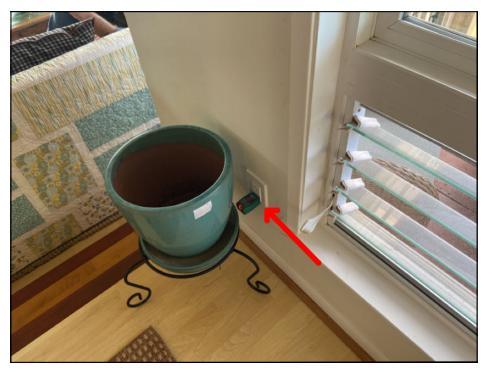
Outlet tester indicates the outlet was not grounded. Repair, replace or update as needed. (Red) Location: dining area.

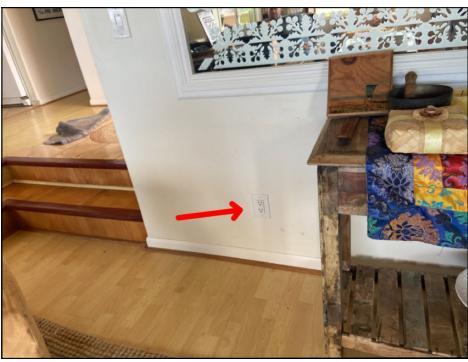
Location: living room.

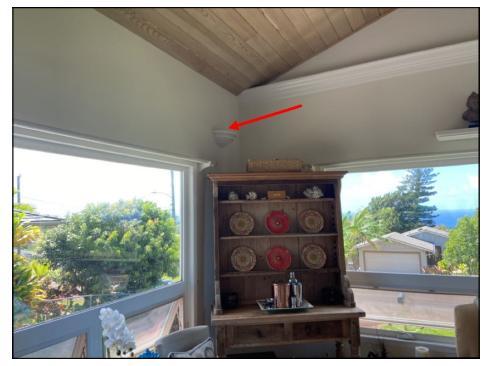
Loose outlets. Tighten. (Red) Replace dead or missing light bulbs. Test fixtures for proper operation. (Blue) Location: living room.

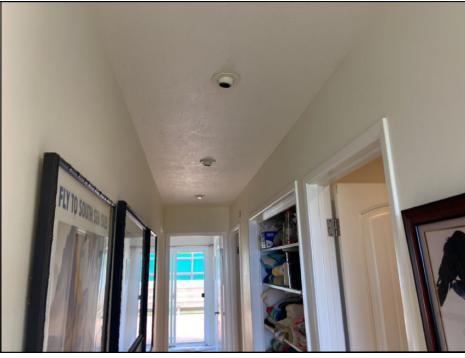
Replace dead or missing light bulbs. Test fixtures for proper operation. (Blue) Location: hallway.

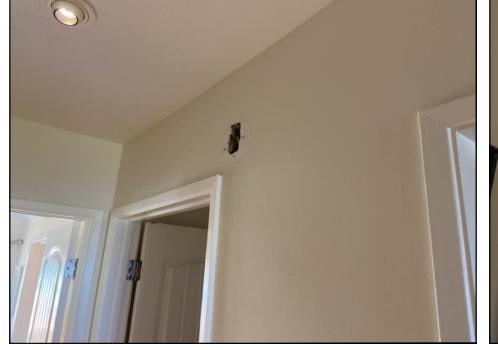
Install covers at open junction boxes. (Red)

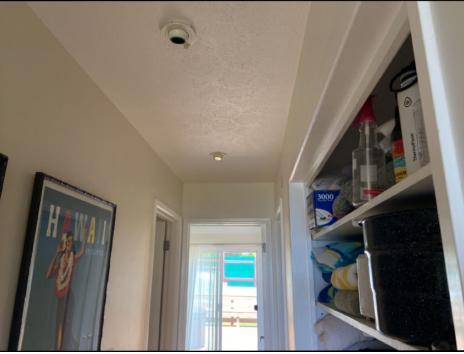
Smoke detectors not present. Recommend installing at currently required locations. (Red)

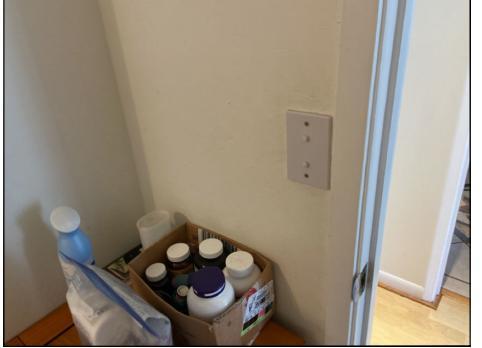
Flicker switch junction box appeared to be abandoned. Location: quest bedroom.

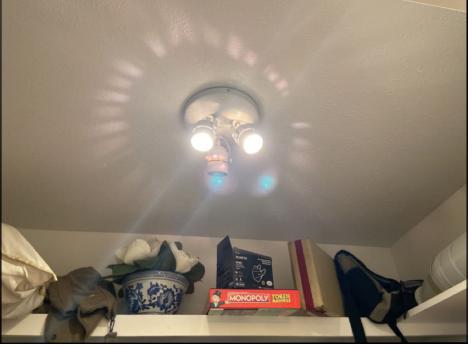
Replace dead or missing light Replace dead or missing light bulbs. Test fixtures for proper operation. (Blue) Location: master bathroom closet.

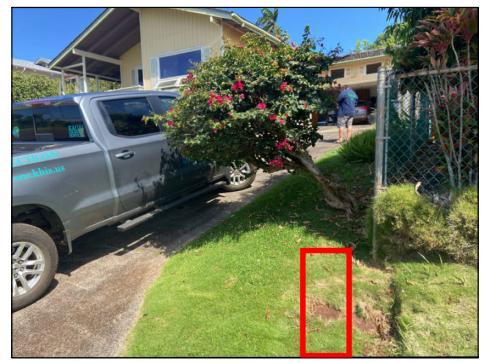
Water meter and main shutoff valve. Location: front of home.

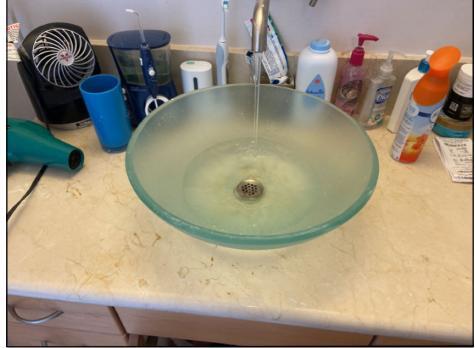
Slow drain accumulates water when in use. Repair. (Blue) Location: master bathroom.

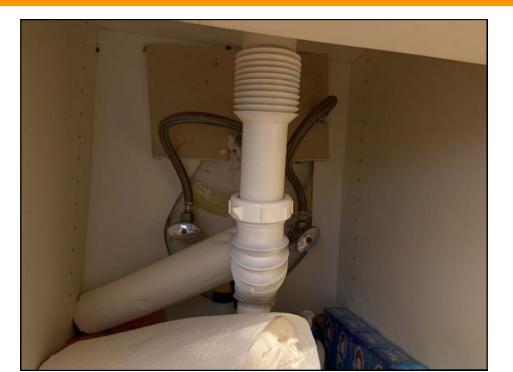
Flexible drain lines are subject to clogs and cracks. Replace with standard materials. (Blue) Location: master bathroom.

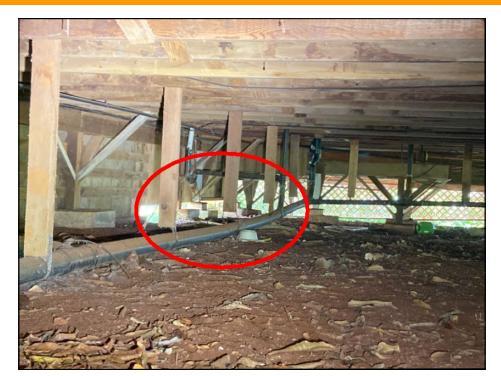
The bracing/strapping at drain lines at foundation area was corroded and/or not present to maintain proper slope of the drain line. Repair or replace as needed. (Red)

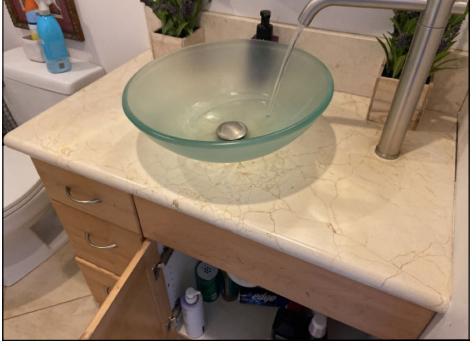
Sink fixture was unsecured to the countertop. Evaluate. Repair or replace as needed. (Red) Location: guest bathroom.
