PROPERTY INSPECTION REPORT

Client: Jane Aardvark Property: 11160 Trails End Ct Rancho Cucamonga, HI 91737 Date: 2/20/2021 - Time: 07:00 AM

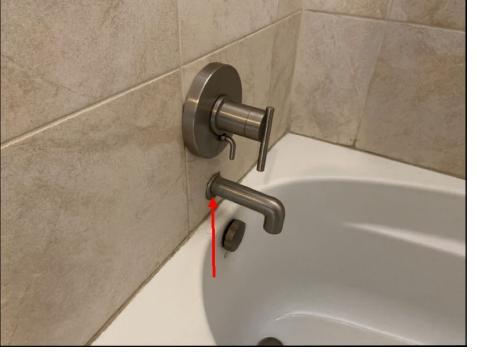
Seal tub spout to wall to prevent moisture intrusion. (Blue) Location: guest bathroom.

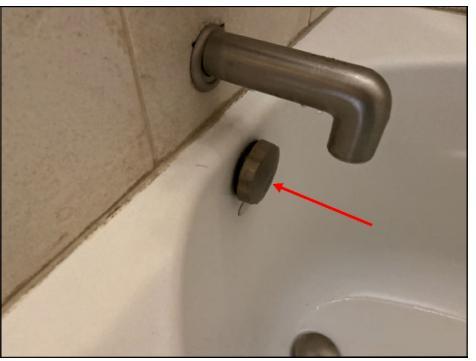
Loose tub overfill drain cap. Repair or replace as needed. (Blue) Location: guest bathroom.

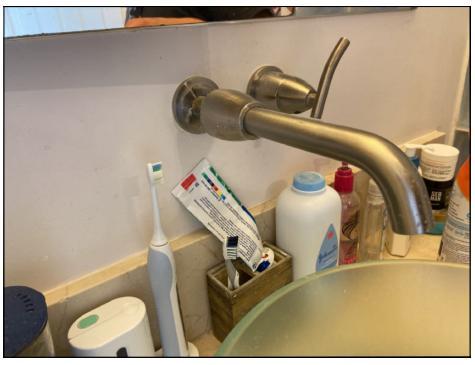
Loose sink wall cover hardware. Repair or replace as needed. (Blue) Location: master bathroom.

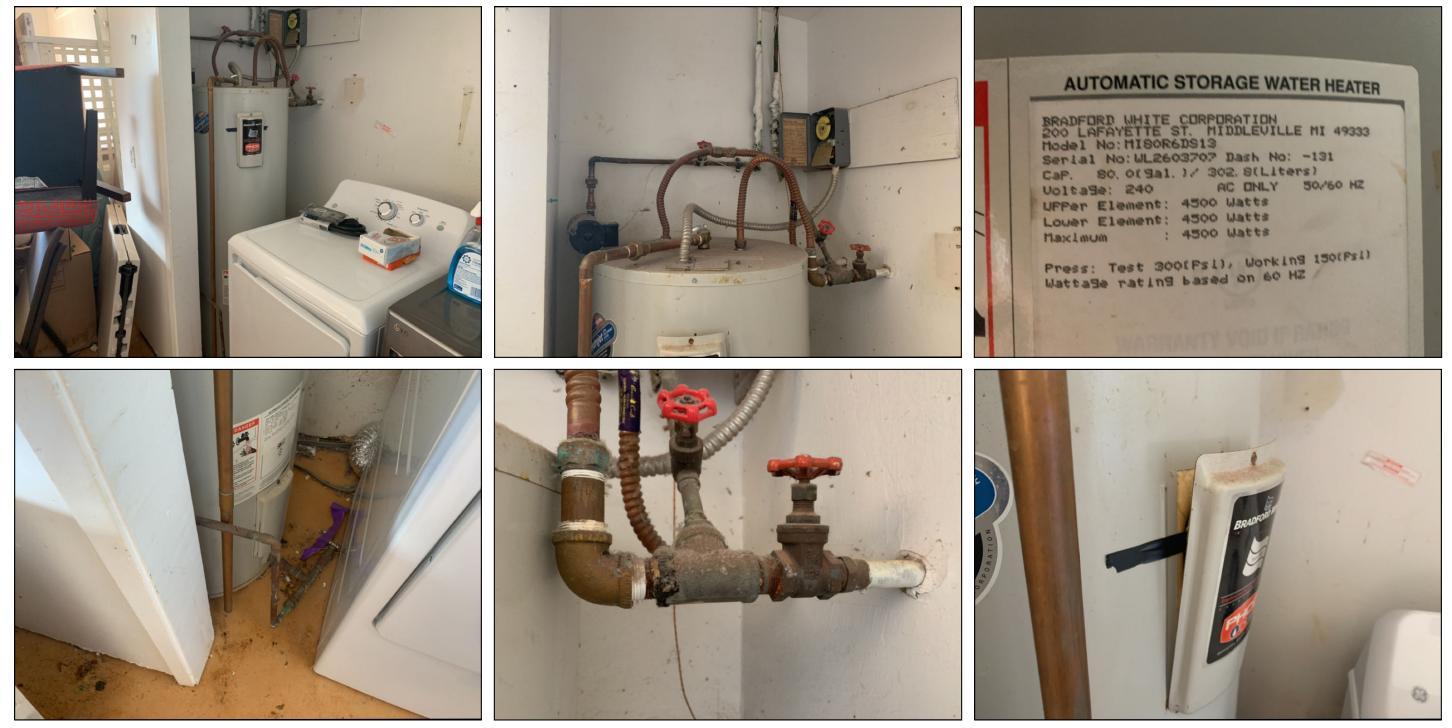
Loose thermostat cover with tape at thermostat. Evaluate. Repair or replace as needed. (Red)

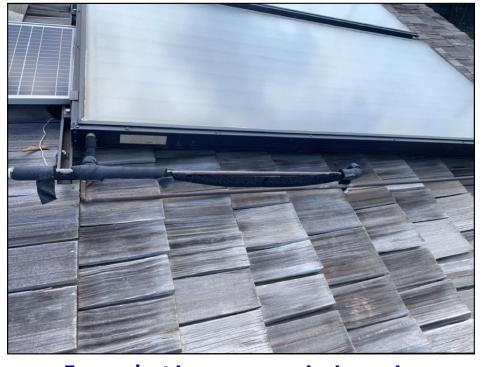
Insulation on piping is deteriorated. This results in heat loss and may cause injury if touched. Replace insulation. (Blue)

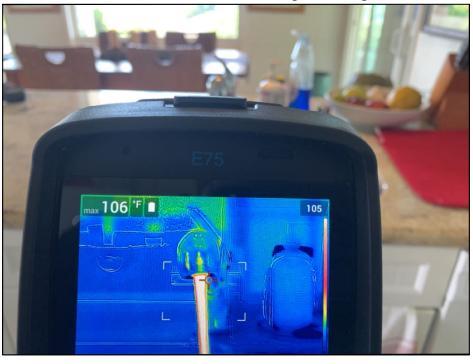
FUEL TANKS AND LINES:

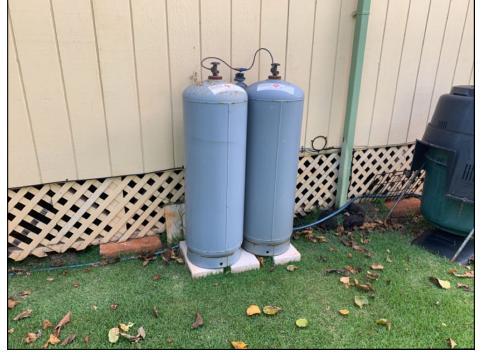
A permanent concrete pad and strapping should be installed at fuel tank(s) to prevent tipping and damage. (Red)

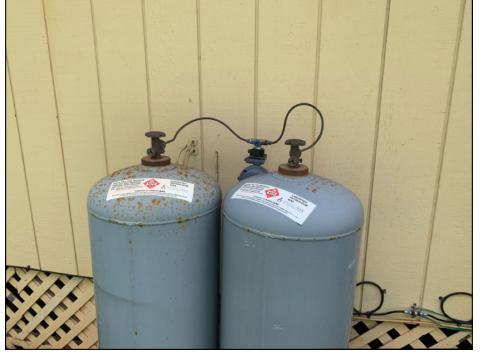
Fuel supply shut off valves.

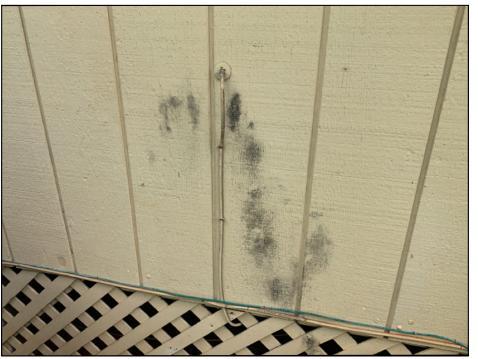
Mold like substance common to tropical climates was observed at walls or roof eaves. Clean and maintain as needed. (Blue)

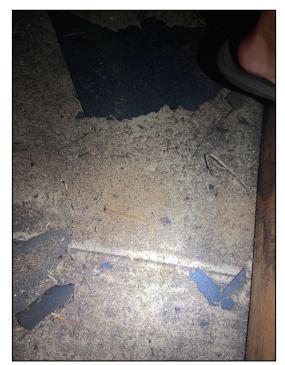
Possible indications of wood destroying organisms or other pests. (Blue) Location: attic.
