Accurate Inspections Inc. Property Inspection Report

1221 N. Harvest Walk Dr, La Puente CA, 91555 Inspection prepared for: John Felix & Jan Felix Agent: Jane Smith - Smith Realty

Inspection Date: 8/1/2007 Time: 3:30 to 5:45 Weather: Sunny

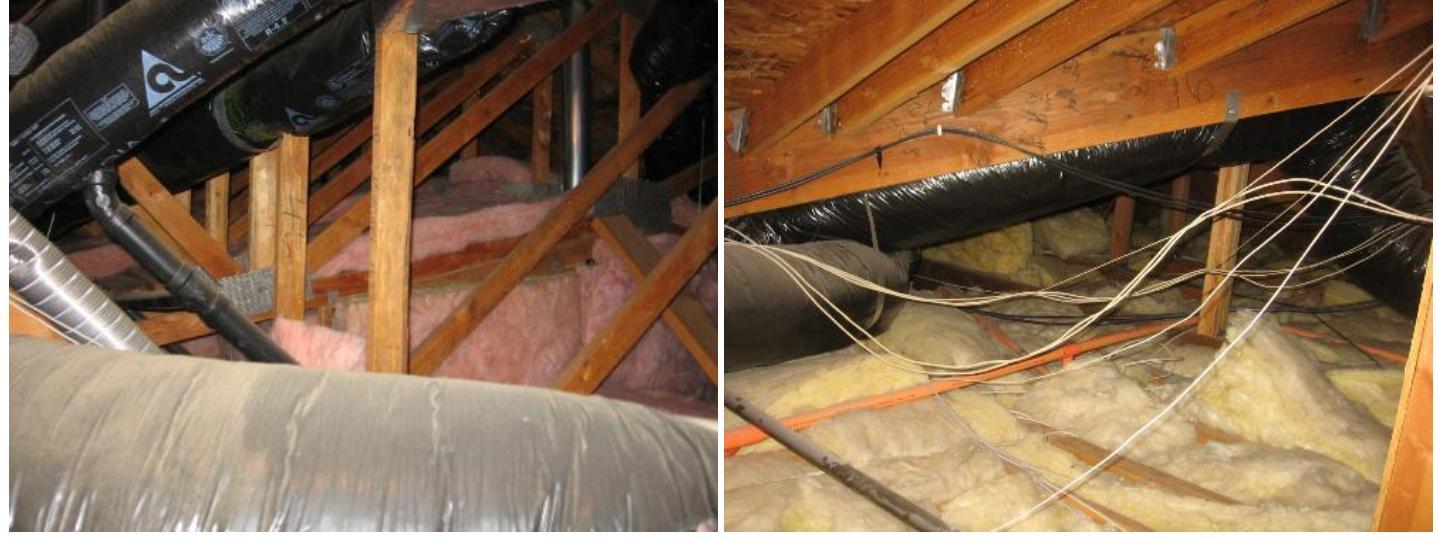
Attic								
1. Access								
Fair	Poor	N/A	None	Observations: The attic was accesible through the master bedroom closet.

Attic Access

Attic view

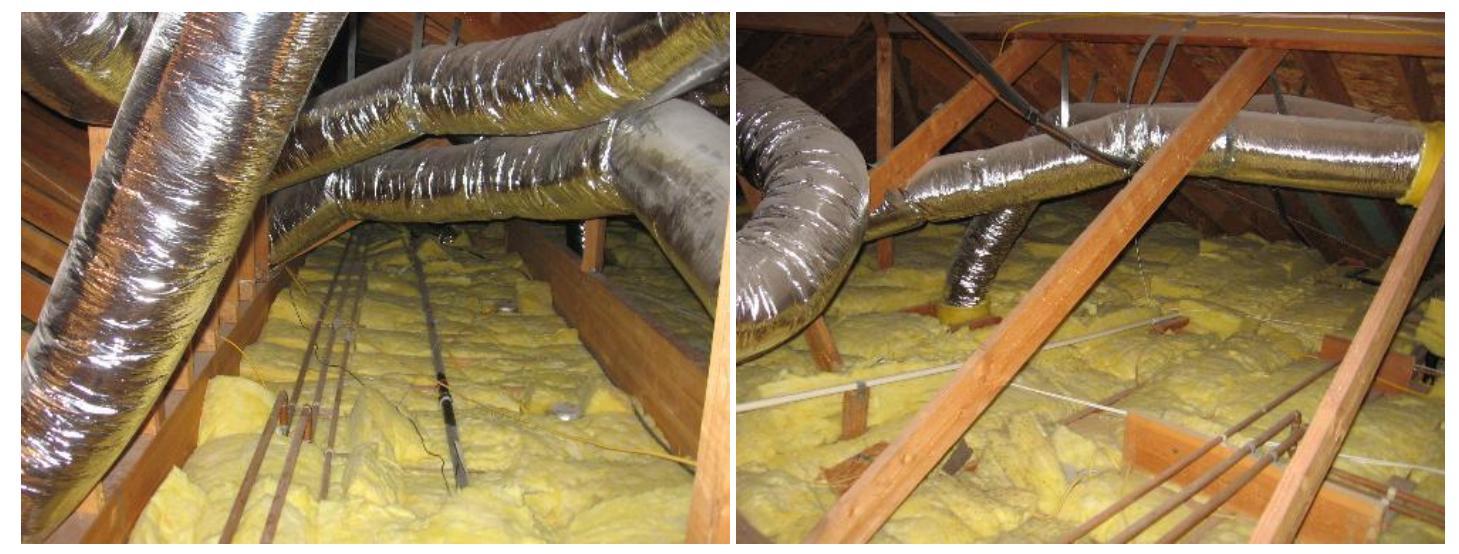
Observations: The duct work appeared functional. For a thorough inspection I recommend an evaluation by a Heating & A/C contractor.

Attic Duct Work

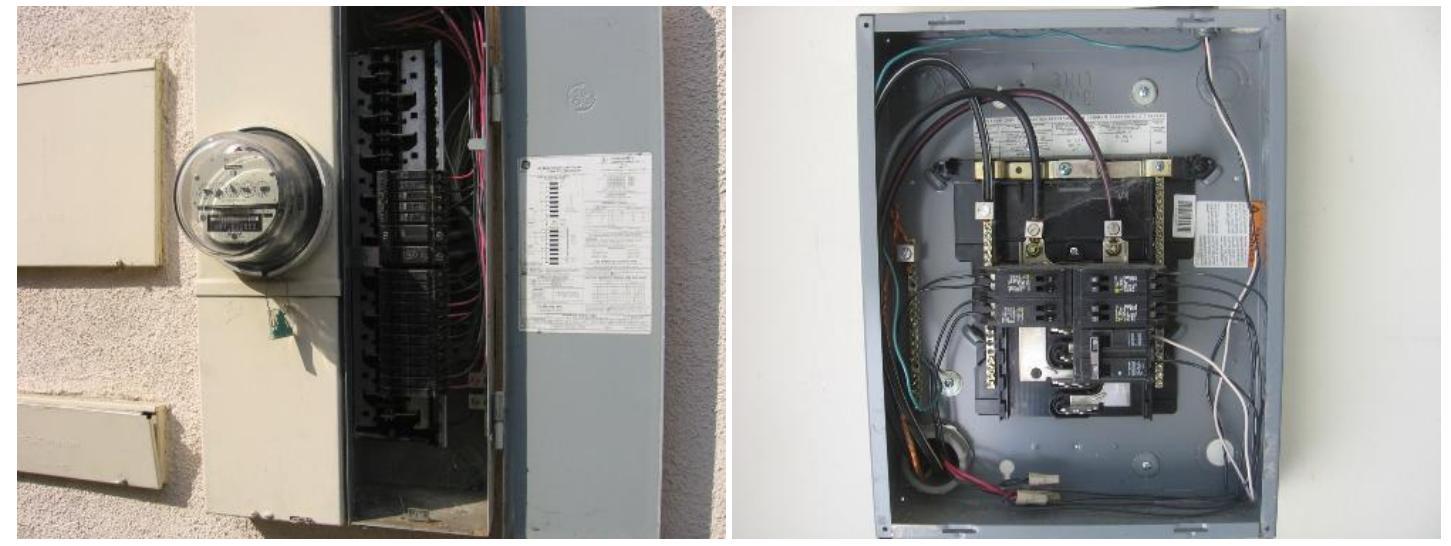
Electrical		
1. Electrical Panel							
Good	Fair	Poor	N/A	None	⊓Materials: Main Location: , east side		
Х					Observations: Undersized wires to a breaker., There was evidence of water		
					within the panel., I reccommend having a licensed electrician evaluate., 14

gauge wire runs to a 30 amp breaker, improper electrical installation, Undersized wires to a breaker.

Electrical Panel

Electrical Sub Panel

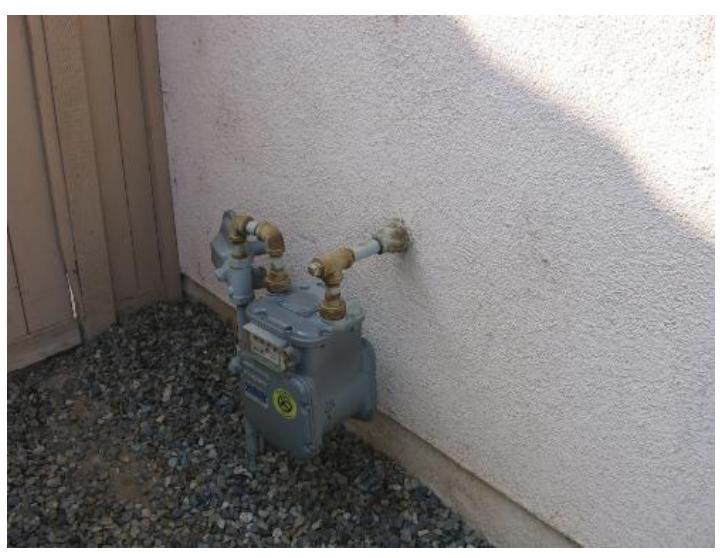
Main Gas Valve

Good	Fair	Poor	N/A	Materials: east side
X				Observations: Main gas into the house is natural gas., No seismic shut off
				present., I recommend having the Gas Company evaluate the valve.
				present., rrecommend naving the Cas company evaluate the valve.

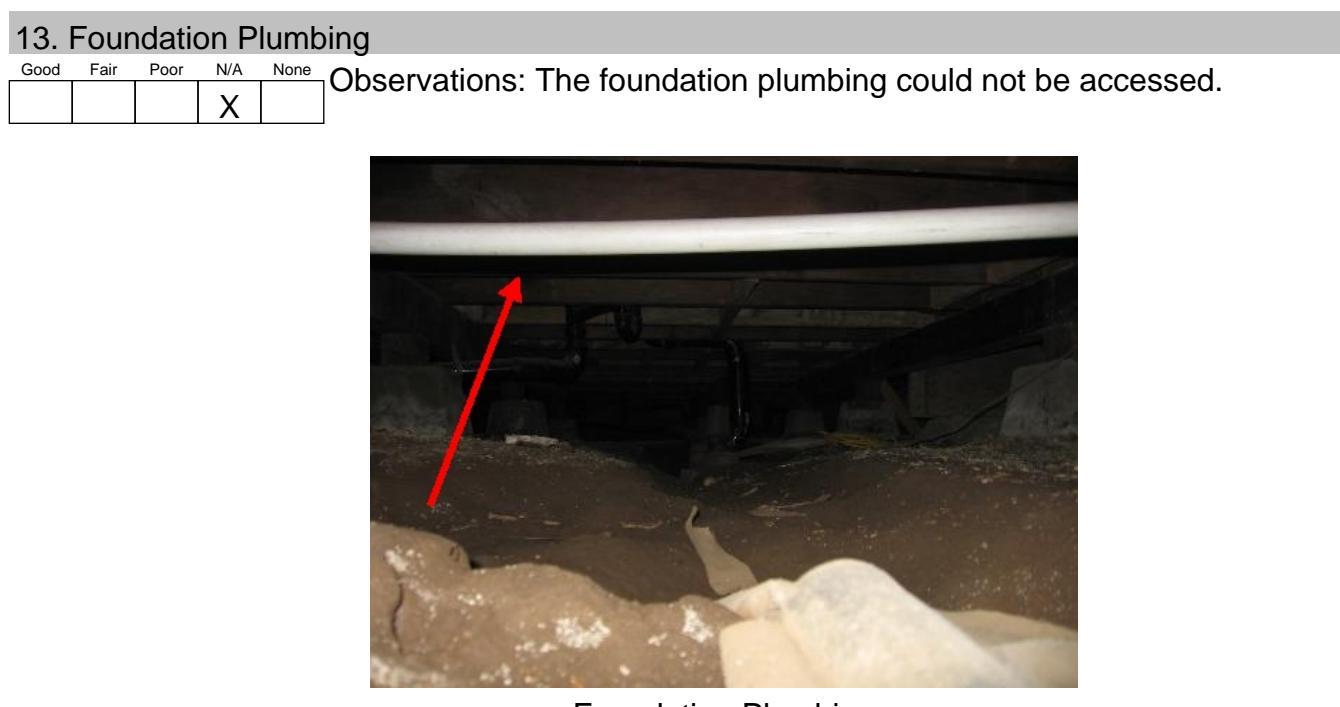
Foundation Plumbing

Exposed electrical connections. Missing junction box cover.

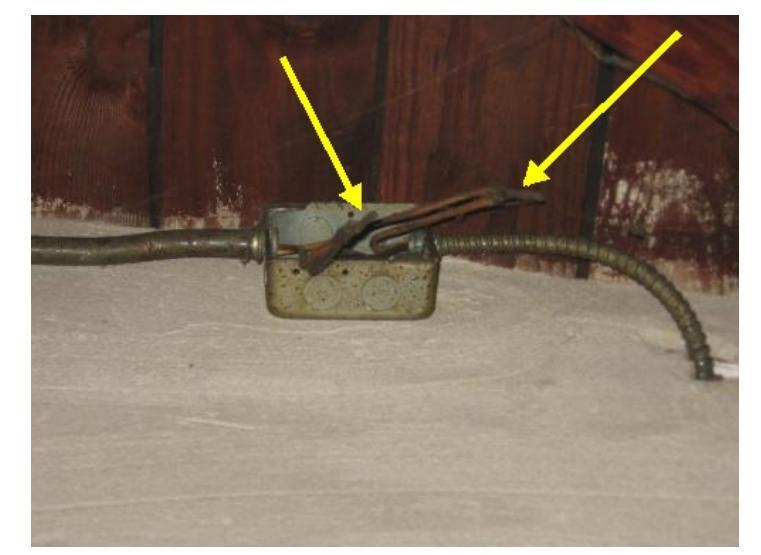
Missing wire nuts

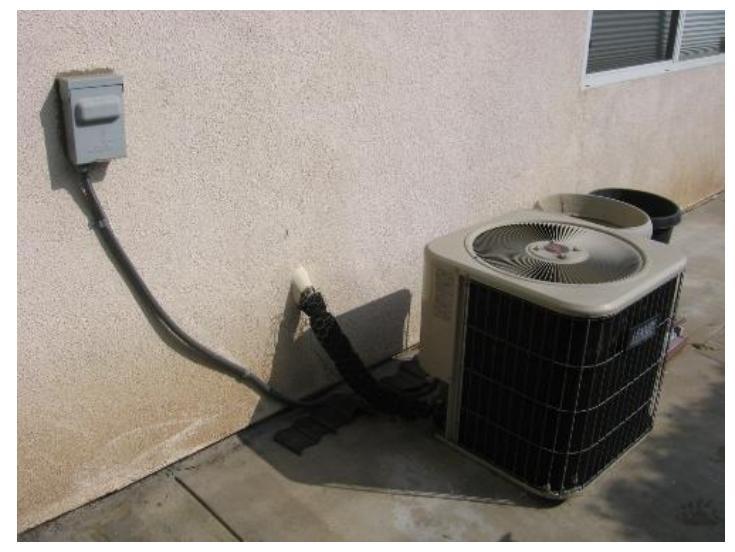
Heating AC Compress Condition

5. Thermostats
Good Fair Poor N/A None X Image: Second seco
6. Venting
Good Fair Poor N/A None Observations: The vent could not be fully inspected due to personal items in way
7. Filters
Good Fair Poor N/A None Observations: Filters were dirty. I recommend replacing the filters to ensure proper function of the heating system
8. Air Supply
Good Fair Poor N/A None Observations: The air supply was functional and in a good location
9. Registers
Good Fair Poor N/A None X Deservations: The air registers were functional
10. Refrigerant Lines
Good Fair Poor N/A None Observations: Refrigerant lines could not be fully inspected due to X I I I I I I I I I I I I I I I I I I
11. AC Compress Condition
Good Fair Poor N/A None Materials: electric
X Materials: patio area Observations: A/C Compressor operated at 49 degrees
