Accurate Inspections Inc.

Property Inspection Report

1221 N. Harvest Walk Dr, La Puente CA, 91555
Inspection prepared for: John Felix & Jan Felix
Agent: Jane Smith - Smith Realty

Inspection Date: 8/1/2007 Time: 3:30 to 5:45
Weather: Sunny

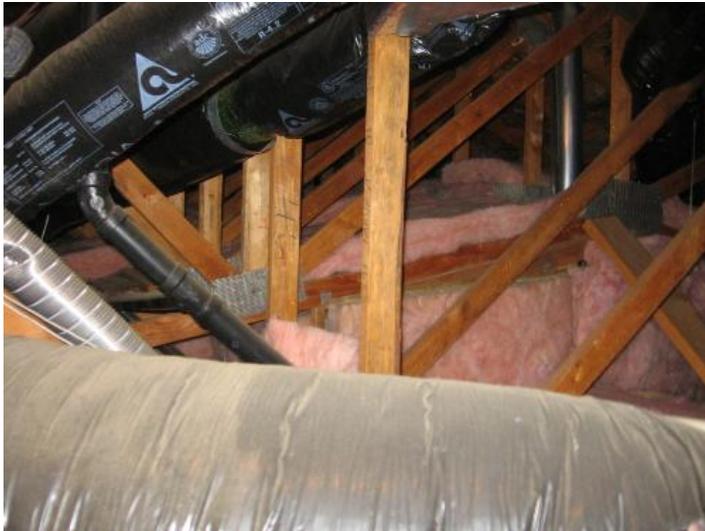
Attic Access

Observations: The attic was accesible through the master bedroom closet.

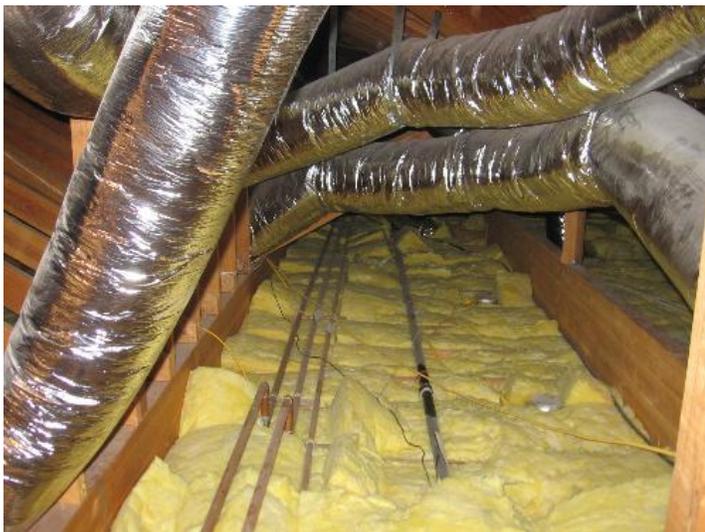
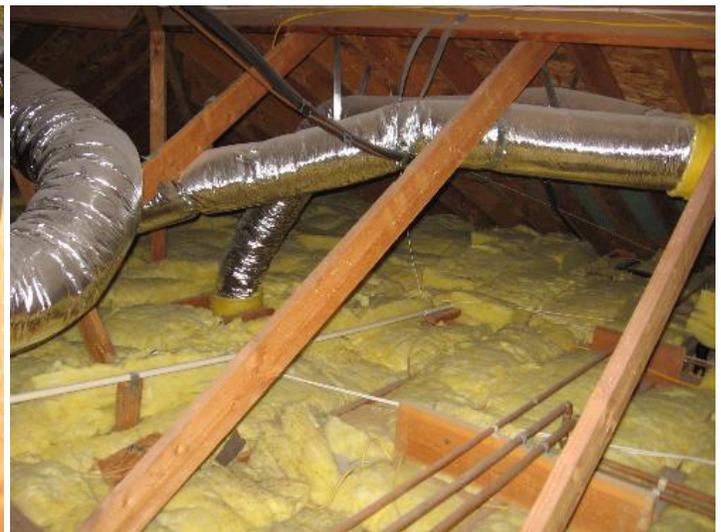
Attic Duct Work

Observations: The duct work appeared functional.
For a thorough inspection I recommend an evaluation by a Heating & A/C contractor.

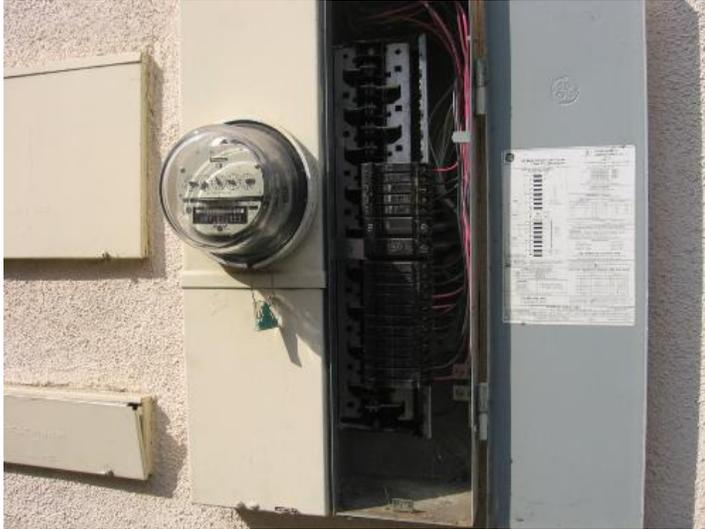
Electrical Panel

Materials: Main Location: , east side
 Observations: Undersized wires to a breaker., There was evidence of water within the panel., I reccommend having a licensed electrician evaluate., 14 gauge wire runs to a 30 amp breaker, improper electrical installation, Undersized wires to a breaker.

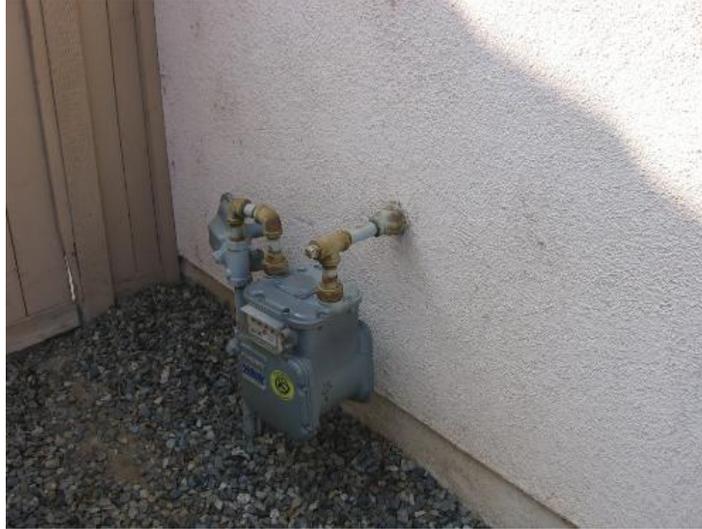
Main Gas Valve

Observations: Main gas into the house is natural gas., **No seismic shut off present., I recommend having the Gas Company evaluate the valve.**

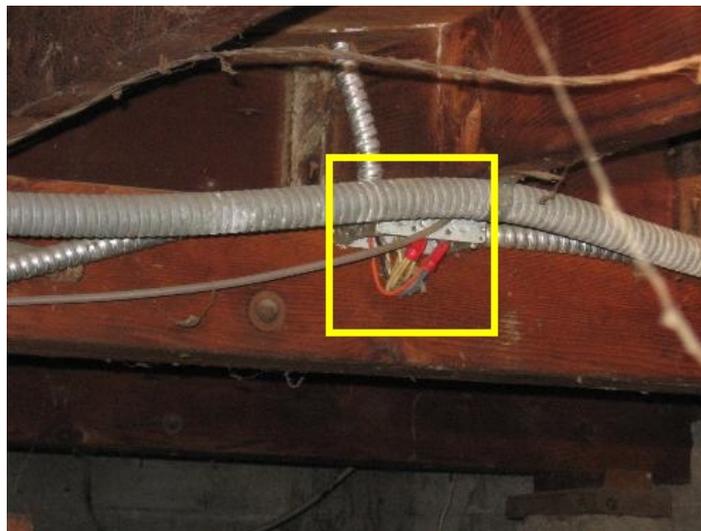
Exposed electrical connections. Missing junction box cover.

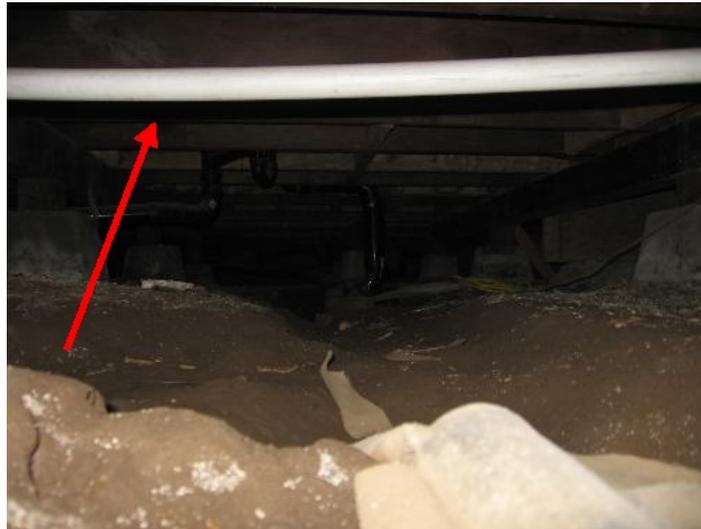
Foundation Plumbing

Observations: The foundation plumbing could not be accessed.

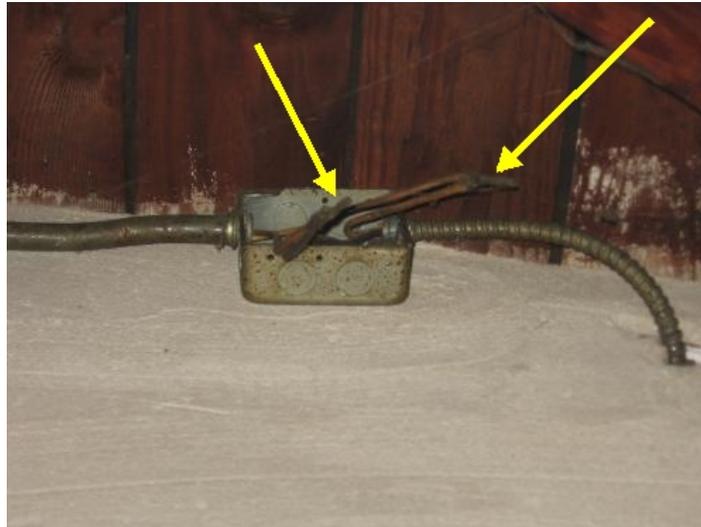
Missing wire nuts

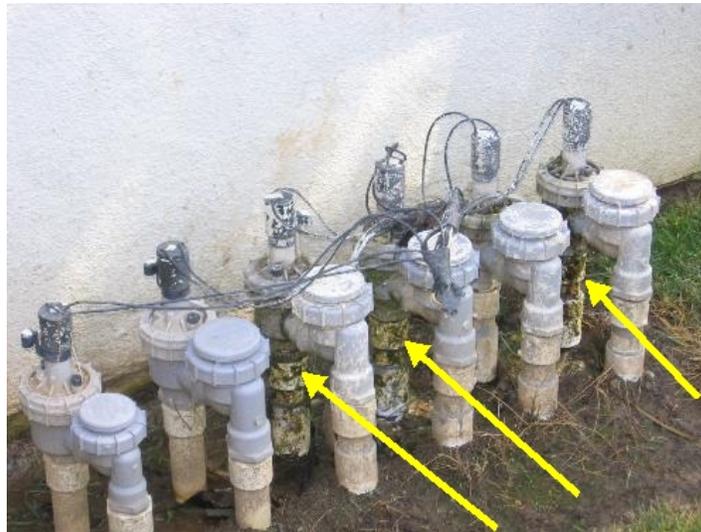
Visible leaking of sprinkler valves.

Visible leaking

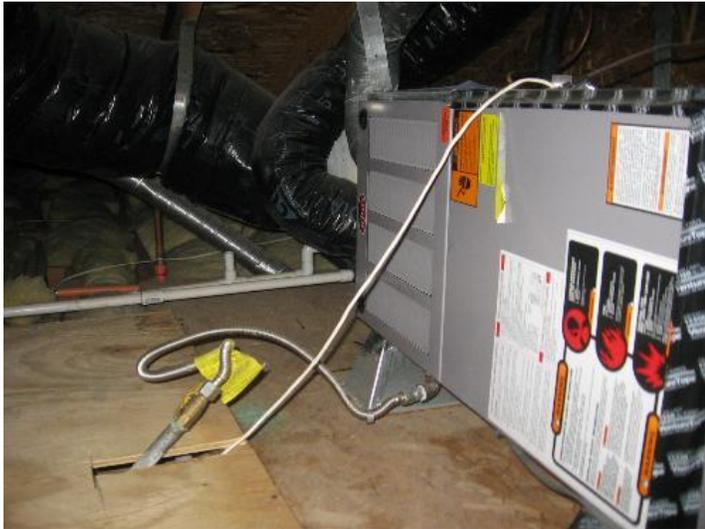
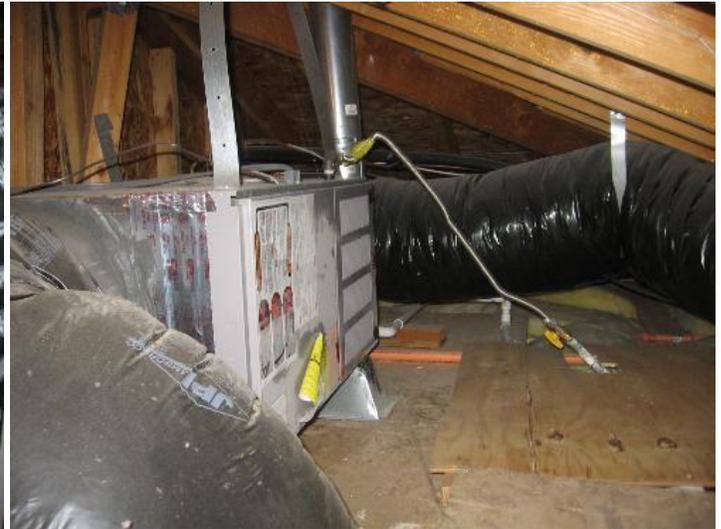
Heater

Observations: The water heater was functional. **The unit does not have proper clearance. The walls to it's side are too close**

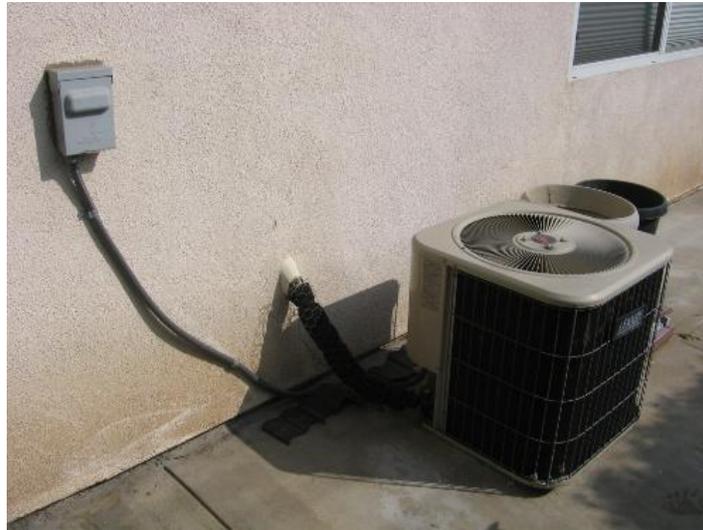
Heating AC Compress Condition

Observations: A/C Compressor operated at 49 degrees

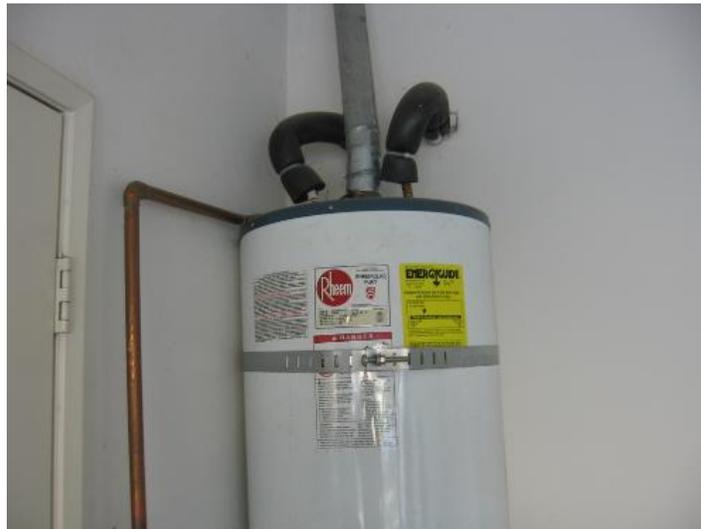
Water Heater

Observations: Water heater base has moisture present.

Observations: Water heater operated normally., Evidence of leaking was seen on the water heater base.

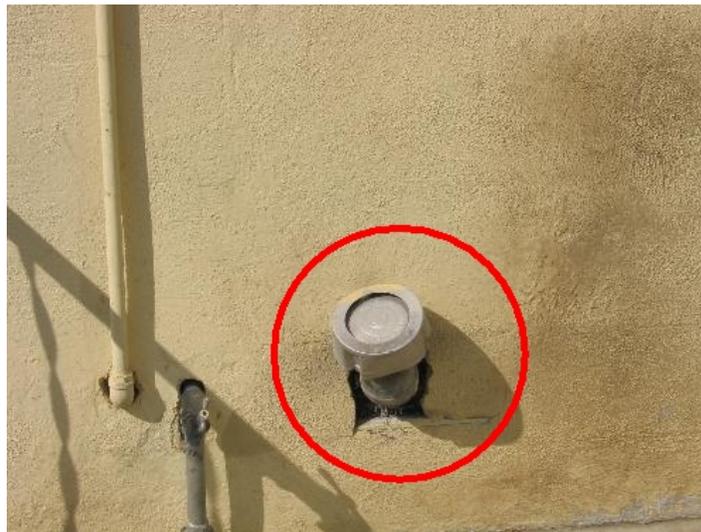
Observations: The vent could not be fully inspected

Improper installation of vent pipe. Exhaust vent from water heating in the basement area.
