Bob's Inspections Property Inspection Report

9555 W. Cucamonga - Buildings A to T Units 1 to 330, San Francisco CA,

Inspection prepared for: Some Big University Inspection Date: 2/1/2007

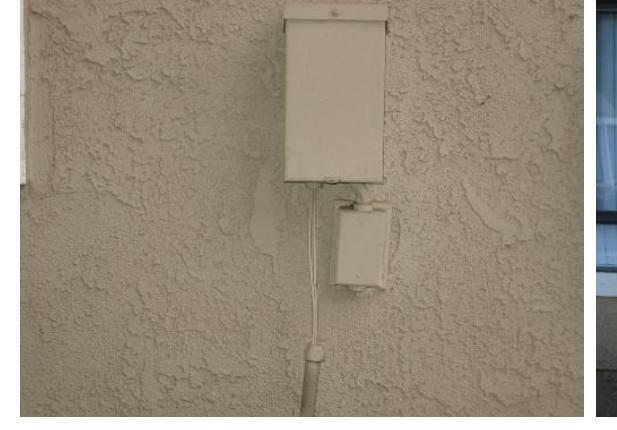
Heater/AC - Electrical Disconnect Box

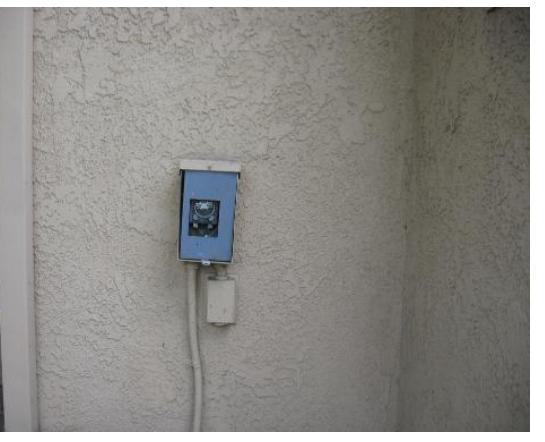
Heater/AC - Disconnect Box

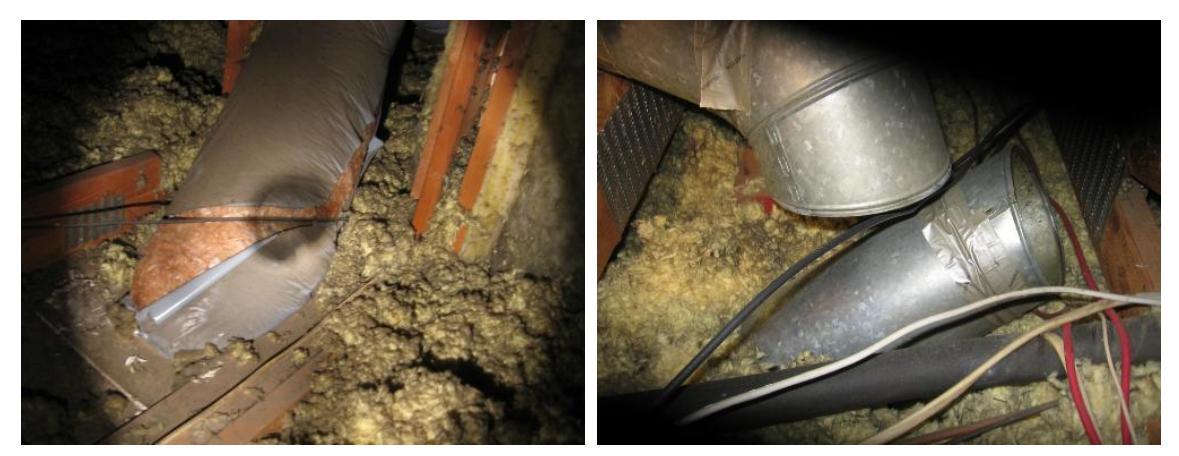
Attic - Ducting

Attic - Exhaust Vent

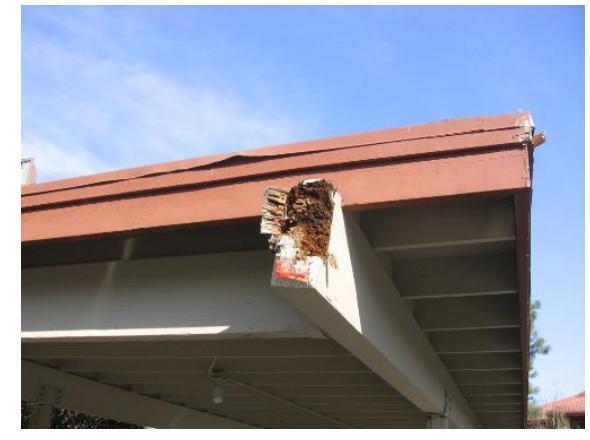
8. Car Port Roofing Condi	ition
X nori to 1 to 2 sho parl	servations: damaged wood on the end of the support beam car port C th side of the complex, deteriorated sheeting parking area 101 to 106, 184 191 and 192 to 197, evidence of leaking parking area 119 to 126 and 211 214, split roofing membrane parking area 267 to 272, all parking areas by asphault and membrane seperation from the metal edge flashing, king areas 170 to 177 and 259 to 266 structure appears to be sagging and ak, all car port areas are in need of service or replacement

Car Port - Damaged Wood

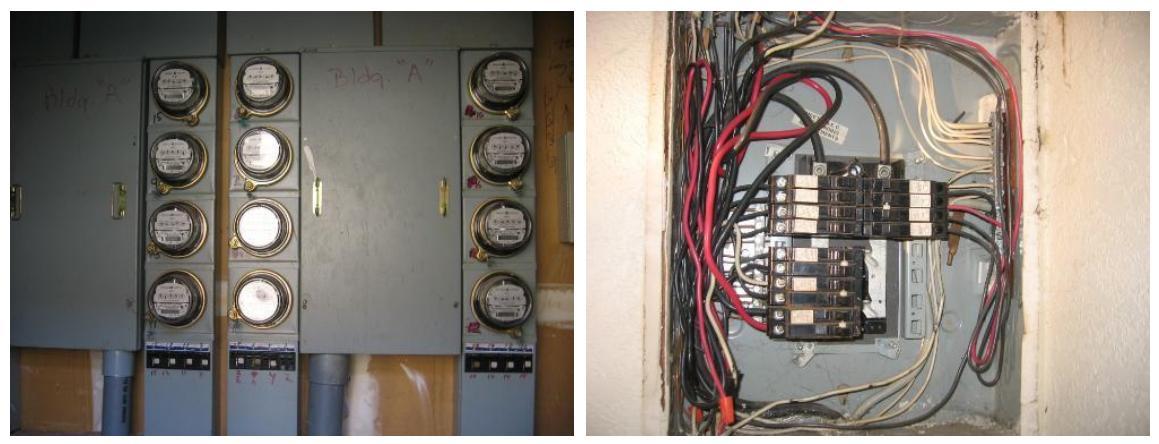
Electrical - Service Panel

Electrical - Sub Panel

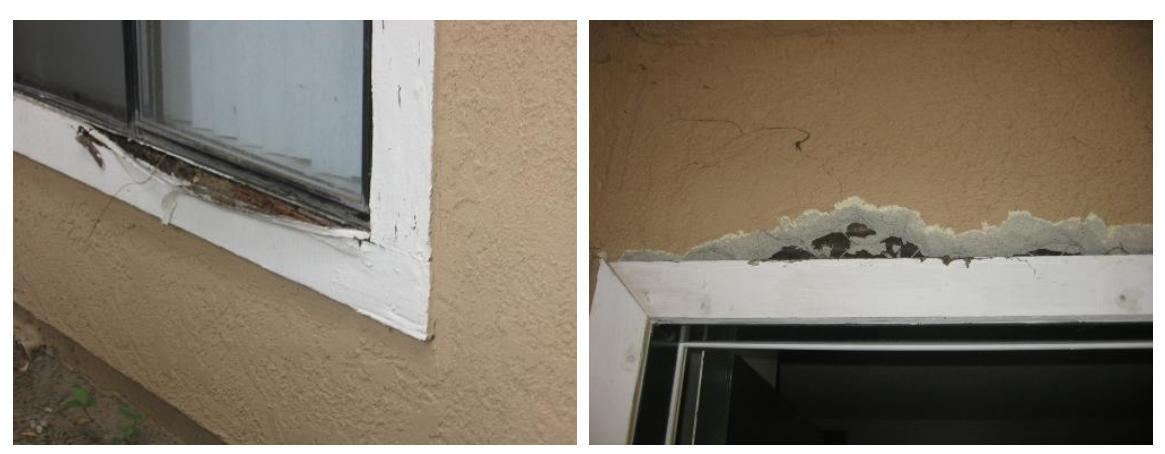
Page 26 Item: 3	Exterior Paint	unpainted areas on the door trim all buildings
Page 26 Item: 4	Siding Condition	deteriorated, loose at the structure window areas on all buildings
Page 26 Item: 5	Stucco	recommend sealing holes & gaps on all buildings where the stucco is missing, wall cap flashing is loose or missing on all buildings patio areas
Page 26 Item: 6	Window Condition	missing, torn and bent screens on all buildings
Foundation		
Page 28 Item: 13	Foundation Plumbing	visible leaking under sub parking area building B, recommend plumber to evaluate all areas
Grounds		
Page 29 Item: 1	Driveway and Walkway Condition	trip hazards on the walkways, lifting due to tree roots, tree roots are damaging curbs at the planters
Page 29 Item: 3	Balcony	lifting & loose wood unit 2,34,92, deteriorated material unit 23, ponding in areas building J east side, deteriorated material building J west side
Page 29 Item: 6	Stairs & Handrail	loose railing, missing lag bolts on most buildings, missing or damaged railing unit 192,174,304, loose steps unit 212

Exterior - Siding

Exterior - Stucco

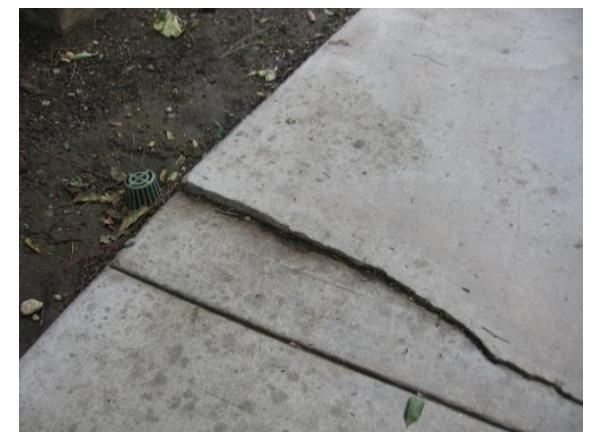
Grounds
1. Driveway and Walkway Condition
Good Fair Poor N/A None X A A A A Observations: stained, small cracking, trip hazards on the walkways, lifting due to tree roots, tree roots are damaging curbs at the planters

Grounds - Walkway

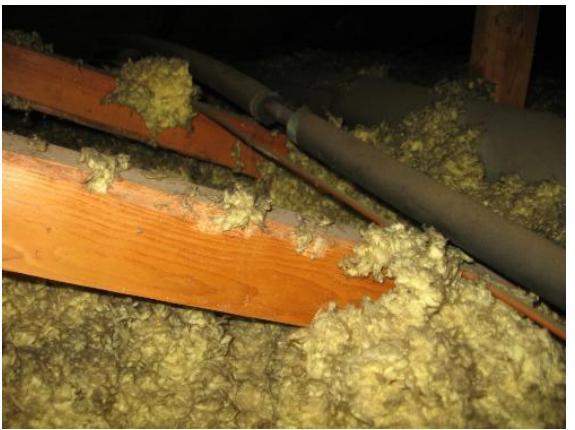
ood	Fair	Poor	N/A	None	Observations: missing insulation at A/C condenser all units irregular
	Y				Observations: missing insulation at A/C condenser all units, irregular installation not supported properly unit 24
	Λ				Installation not supported property unit 24

Heating/AC - Refrigerant Lines

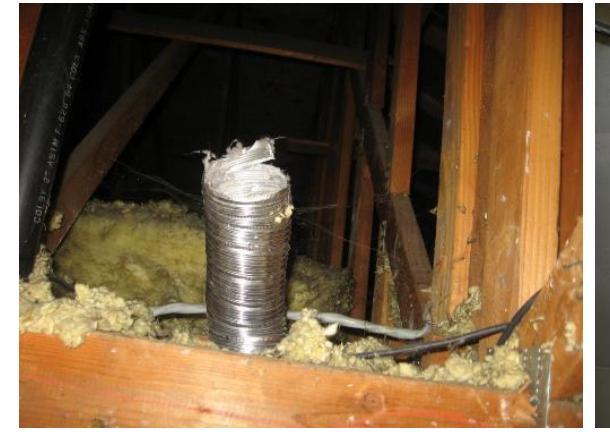
4. Ceiling Condition
Good Fair Poor N/A None Materials: drywall
5. Dryer Vent
Good Fair Poor N/A None Observations: could not fully inspect, could not access most units, vent into the laundry area

Laundry - Dryer Vent

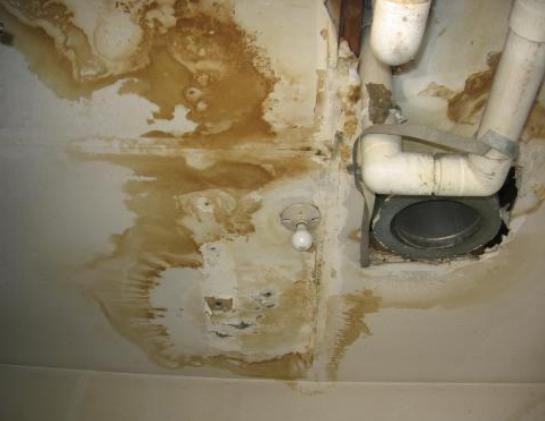
Page 31 Item: 5	Gate & Fence Condition	wood is deteriorated and weak west pool equipment area
	Condition	did not operate, heater not hooked up [west pool], equipment room ceiling by the office is water damaged,stained and missing drywall

Pool - Equipment Room Ceiling

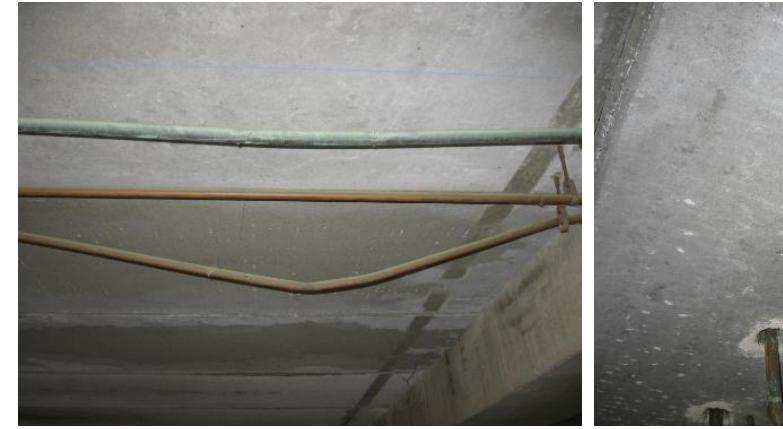
Bob's Inspections	<i>9555</i>	<i>W</i> .	Cucamonga - Building	gs A to T
			Units 1 to 330 San F	rancisco
13. Foundation Plumbing				
Good Fair Poor N/A None Observations: could not access building B, recommend plumbe	s, visible er to eva	e leak luate	king under sub parking area e all areas	
14. Ducting				
Good Fair Poor N/A None

Sub Parking Area - Plumbing

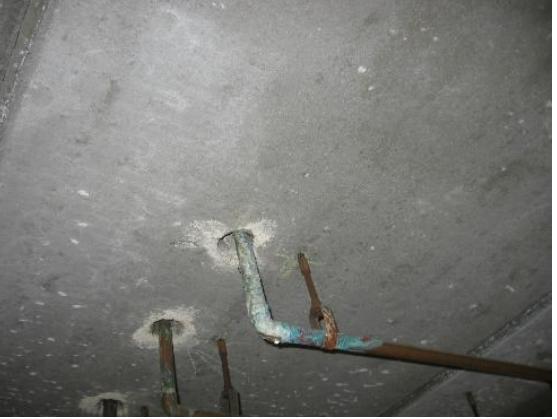
Sub Parking Area - Plumbing

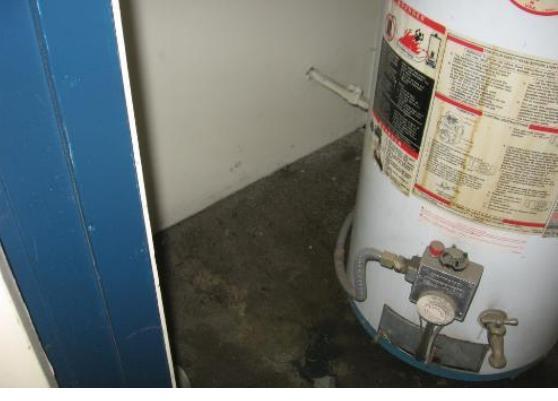
Waterheater	1	
Page 19 Item: 2	Combusion	personal items present and to close to the waterheaters in most of the units
Page 19 Item: 3	Water Heater Condition	visible leaking unit 3,36,79,83,100,104,109,173,187, missing fire box cover unit 2, deteriorated unit 38,51,69,85, recommend drain pans under all second story units
Page 19 Item: 5	Heater Enclosure	deteriorated and split door unit 1,2,3,4,6,8.10,14,15,17,20,22,27,34,36,54,55,56,57,60,65,66, 74,94,97,102,104,105,106,112,114,119,121,122,123,124,127, 128,138,144,146,161,162,167,168,178,184,186,190,192,198, 200,207,209,210,224,232,242,246,251,252,256,257,260,262, 265,272,273,277,280,290,292,293,294,297,299,300,304,307, 308,312,320, damaged drywall and mold stains present unit 1,3,4,6,19,25,26,45,53,73,79,76,121,149,159,162,166,206,20 9,223,232,254,280,292,316 and office stroage area, damaged jamb unit 5,25,33,104,114130,138,144,146,148,160,202,267,319, door sticks at the jamb unit 44, missing outlet cover unit 46,49

Waterheater - Condition

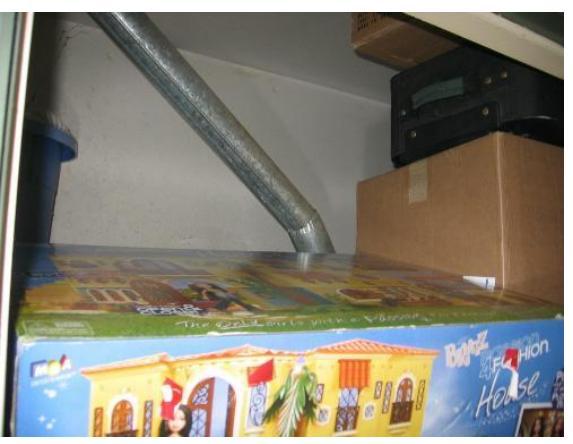
Waterheater - Combustion

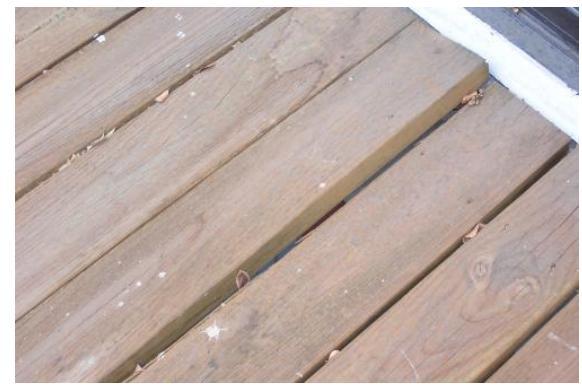
Grounds - Balcony

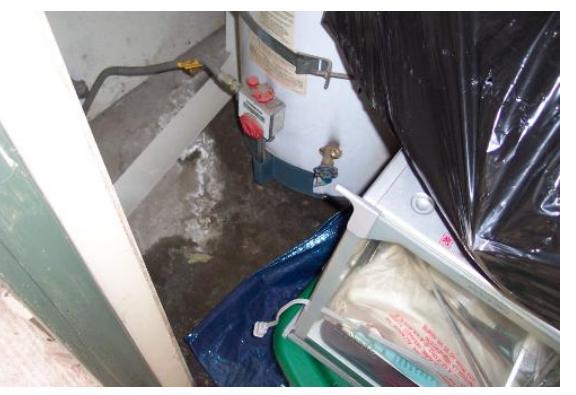
Waterheater - Condition

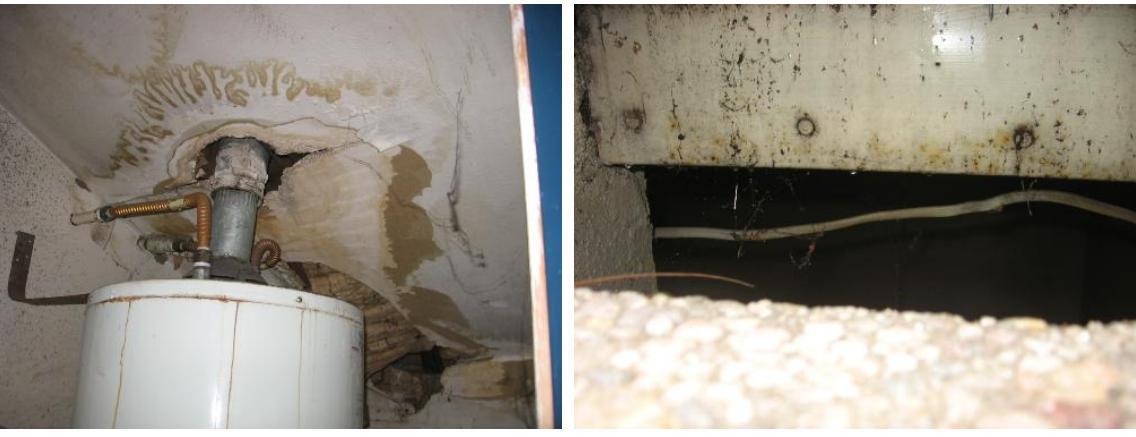
Page 29 Item: 7	Grounds Electrical	missing fixture globes unit 1,41, loose light fixtures on all buildings, exposed romex wiring unit 41 patio area and under the stairs sub parking areas only, recommend all j-boxs at the tennis court and basketball courts are exterior covers and sealed properly
Page 29 Item: 9	Fence Condition	deteriorated wood & post on most units
Page 29 Item: 10	Gate Condition	gate off the hinges east side of the complex
Page 29 Item: 11	Grading	ponding water in many areas of the grounds, trees too close to the structure, trees damaging A/C pads
Page 30 Item: 13	Sprinklers	rec. adjust timer could be over watering and causing the ponding water
Page 30 Item: 16	Water Shut-off Valve Condition	visible leaking at the main shut off unit A, hose bib leaks north side of building N, PRV leaking west side of building D
Pool

Waterheater - Enclosure

Grounds - Electrical Under Stairs

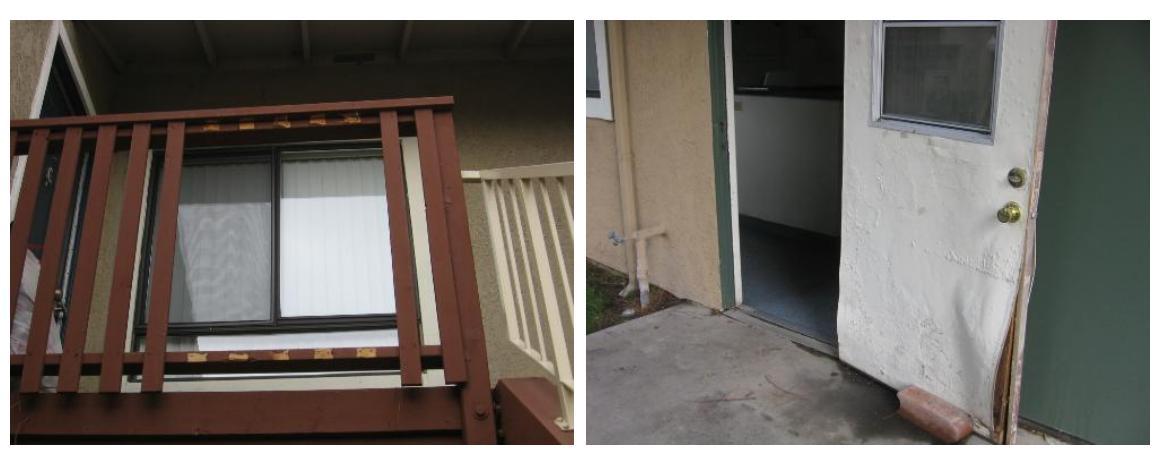
4. Patio Enclosure
Good Fair Poor N/A None
5. Patio and Porch Deck
Good Fair Poor N/A None X A A A A
6. Stairs & Handrail
Good Fair Poor N/A None X X None Observations: loose railing, missing lag bolts on most buildings, missing or damaged railing unit 192,174,304, loose steps unit 212

Grounds - Railing

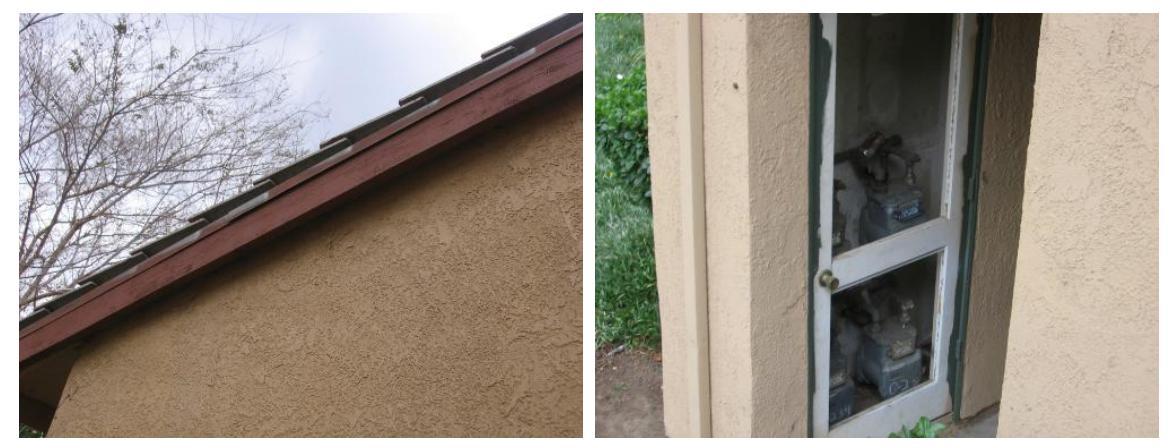
Roof
1. Roof Condition	
X X Obs Lic‡	terials: tile, rock over rolled roofing servations: Roofing Inspection Preformed By James Wright Roofing C39 #641827, chipped, cracked,missing and slipped tiles on all buildings, bosed and deteriorated felt on buildings A,G and L, recommend remove bris from the roof all buildings, recommend a complete service of all Idings

Roof - Condition

Exterior - Doors

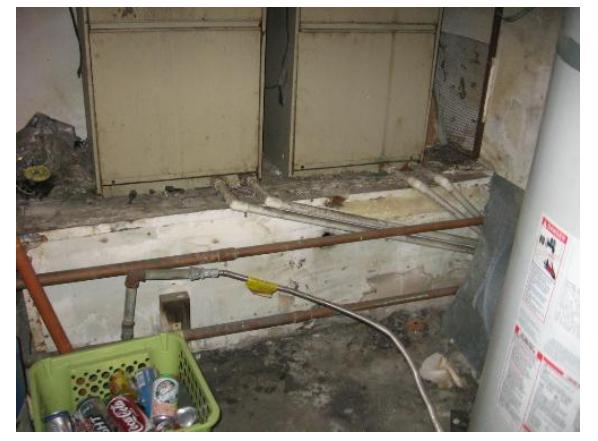
2. Heater Base	
Good Fair Poor N/A None Ob	oservations: damaged drywall, holes in the base, water damaged, office its
3. Enclosure	
Good Fair Poor N/A None

Heating - Heater Base
